Re: Technical Inspection Report, VA0057576

Facility:	Dominion Terminal Associates LLP
County/city:	Newport News

VPDES NO. **VA0057576**

DEPARTMENT OF ENVIRONMENTAL QUALITY
WASTEWATER FACILITY
INSPECTION REPORT
PART 1

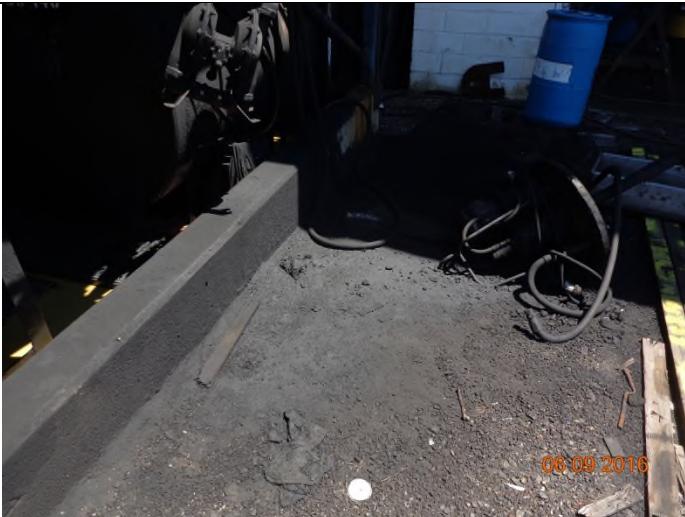
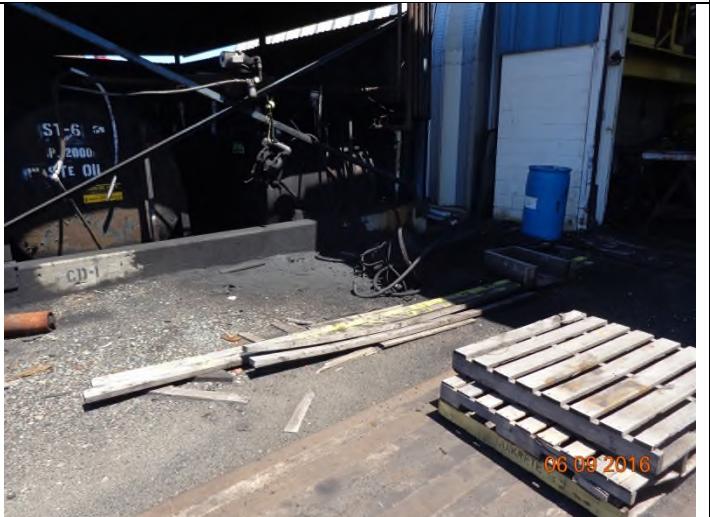
06 09 2016
3) North maintenance building area with stained ground.	4) Same areas as #3, different viewpoint.

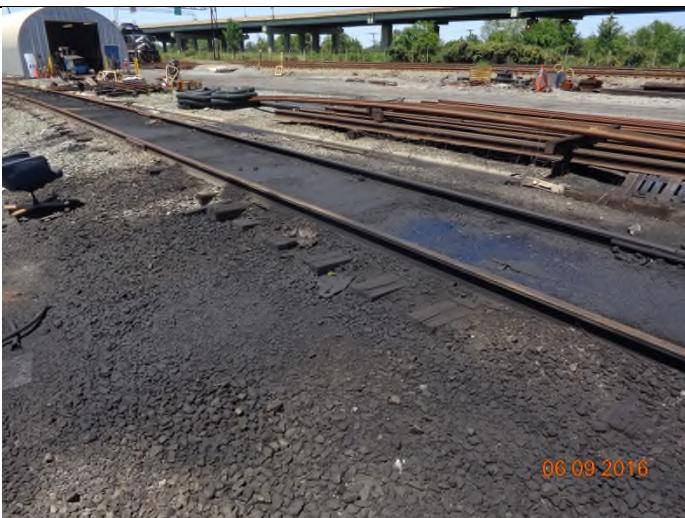
06 09 2016
5) Railroad tracks with petroleum saturated area between the rails leaking to the ballast on each side of the track. This continues to the left and the building in the background.	6) Further down the track from that shown in #5 with other areas of staining.

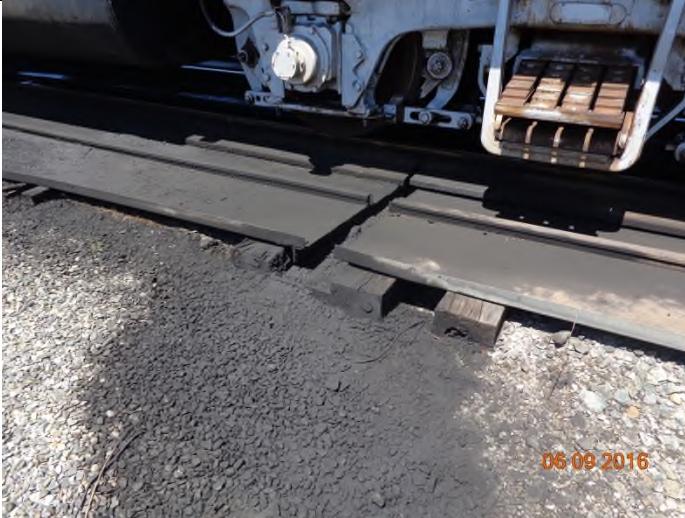
06 09 2016
7) Catch pan for locomotive parking but with a cap in the pan only allows for leakage.	8) Tank labeled locomotive oil with the secondary containment structure almost filled. Oil was observed on the top and appears to be leaking out of the containment structure with a seam found between the two levels of the structure.

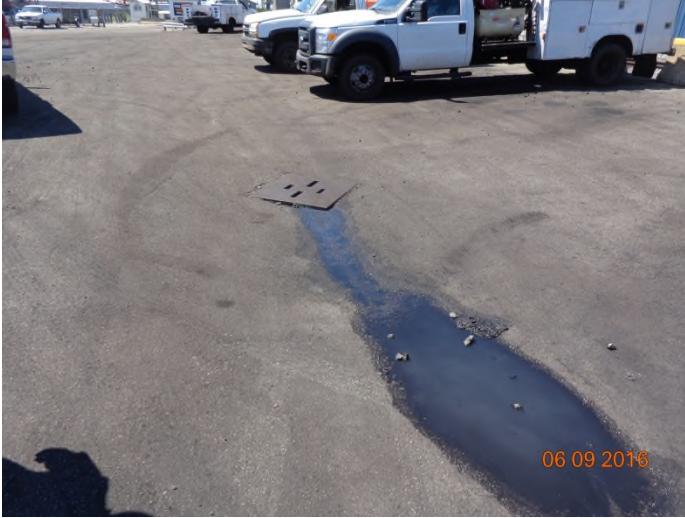
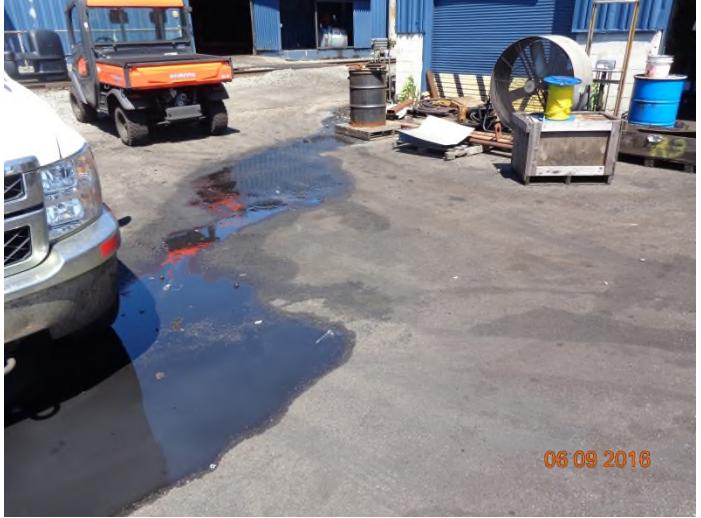
06 09 2016
9) Water flowing to a drop inlet.	10) Source of the water traced along this flow path back to a broken pipe shown in #11.

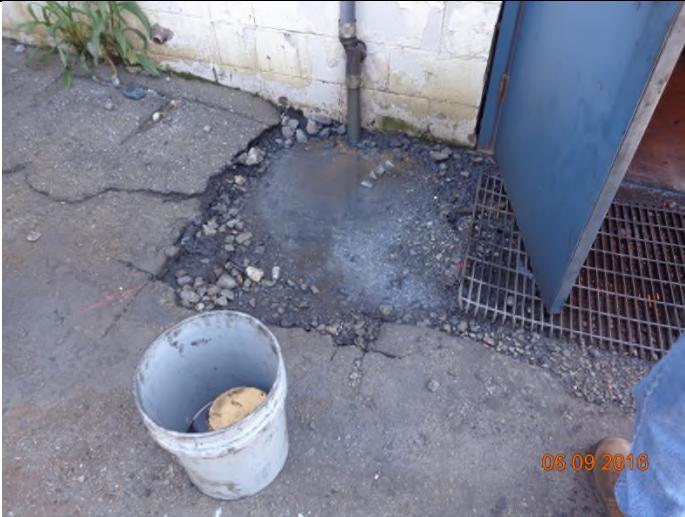
06 09 2016
11) The pipe along the wall is broken open and leaking out onto the ground. This has since been fixed with the flow sent to the sanitary sewer.	12) A small copper tube was discharging water to the sink with the sink connected to the pipe shown in #11. The source of the water was not determined at the time of the site visit.
