VIRGINIA DEPARTMENT OF ENVIRONMENTAL QUALITY

Re: Technical Inspection Report, VA0057576

Facility:	Dominion Terminal Associates LLP
County/city:	Newport News

**DEPARTMENT OF ENVIRONMENTAL QUALITY
INDIVIDUAL PERMIT
INSPECTION REPORT**

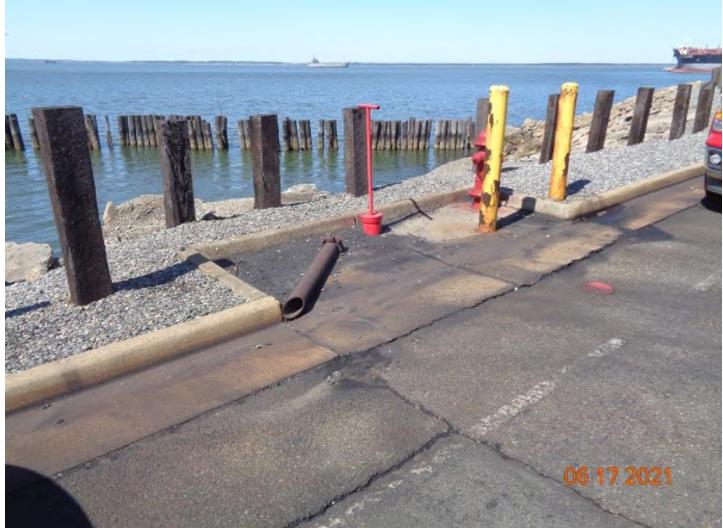
1) South side of Harbor Road, east of the administration building and west of pump station (PS) #2 with a conveyance not show on the site map.

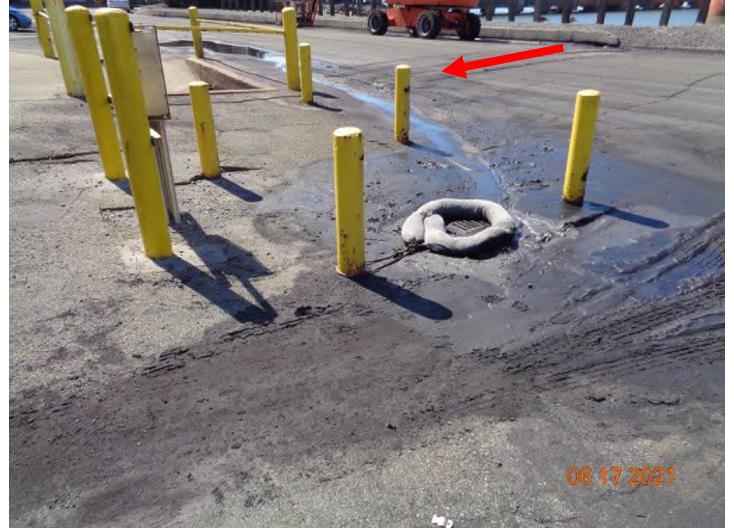
2) Drop inlet and (foreground) and trench drain (arrow) leading to PS #2. The inlet and the pump station is shown on the map, the trench drain is not shown on the map. Sweeping of the area is needed. Cleanup of solids was observed at another location.

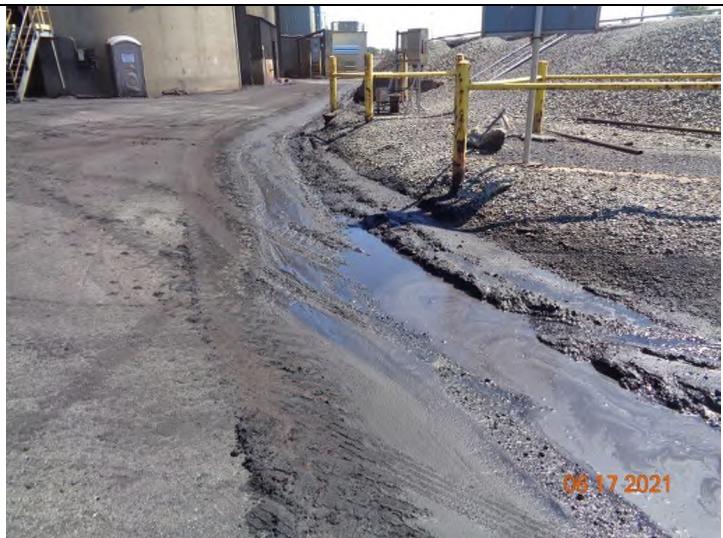
3) View to the north, southeast of the surge silos with coal fines collecting in the concrete swale with discharge to the catch basin shown in photo 4. Cleanup is needed in this area too.

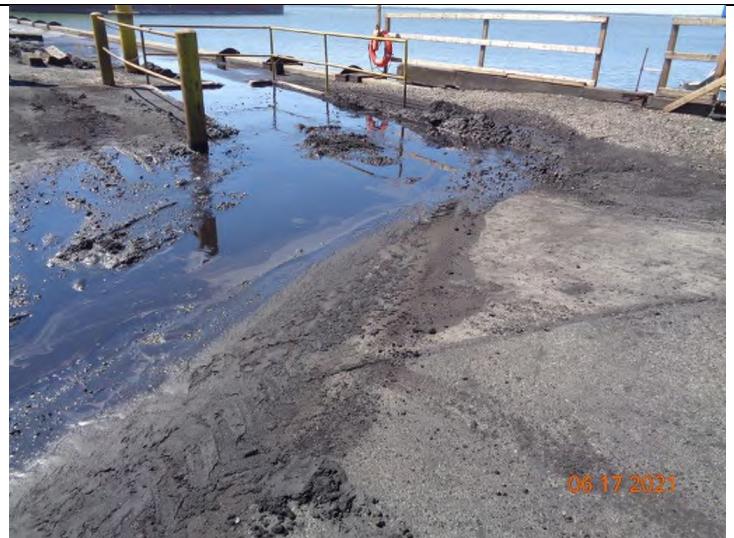
4) Catch basin near pier 11. This and the swale that this drains to is not shown on the map. The water in the photo is the James River.

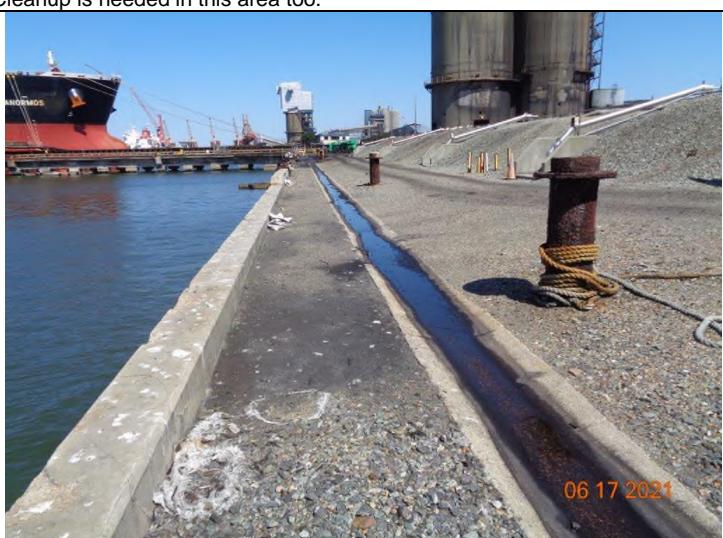
5) Swale along the bulkhead with pier 11 in the background. This drains to PS #3 that then pumps to PS #4 with discharge to Pond 1 or 3.

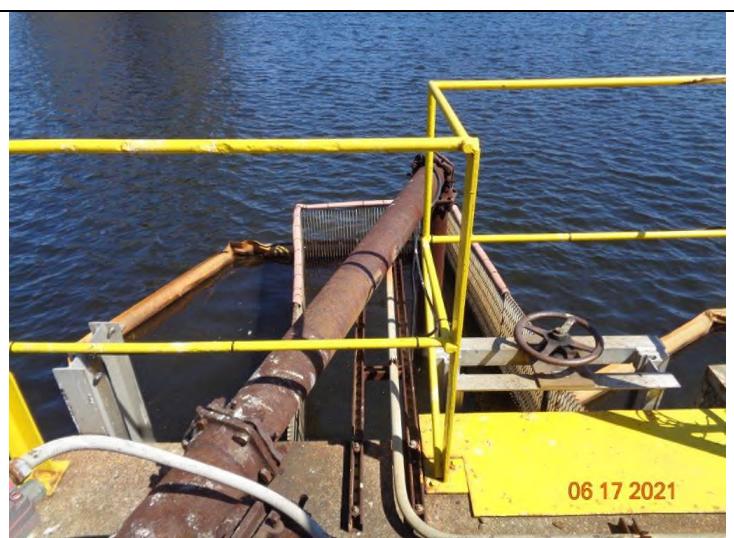
6) Pond 2 effluent piping with discharge to the outfall, shown in photo 7.

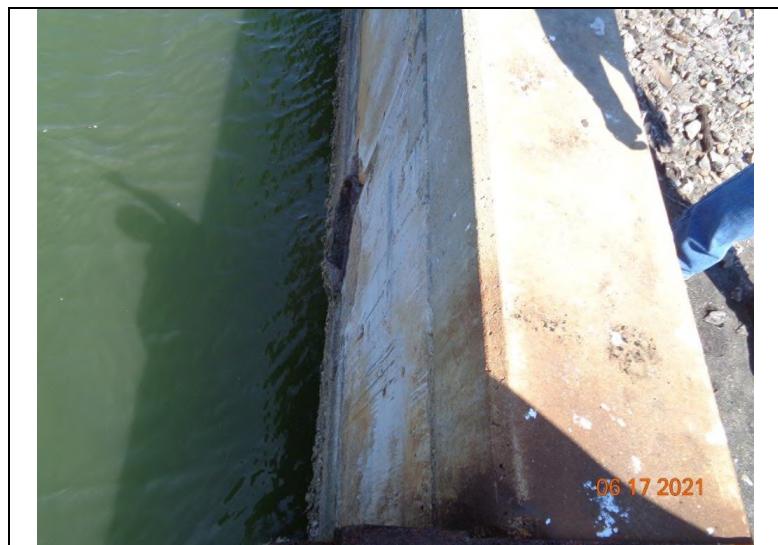
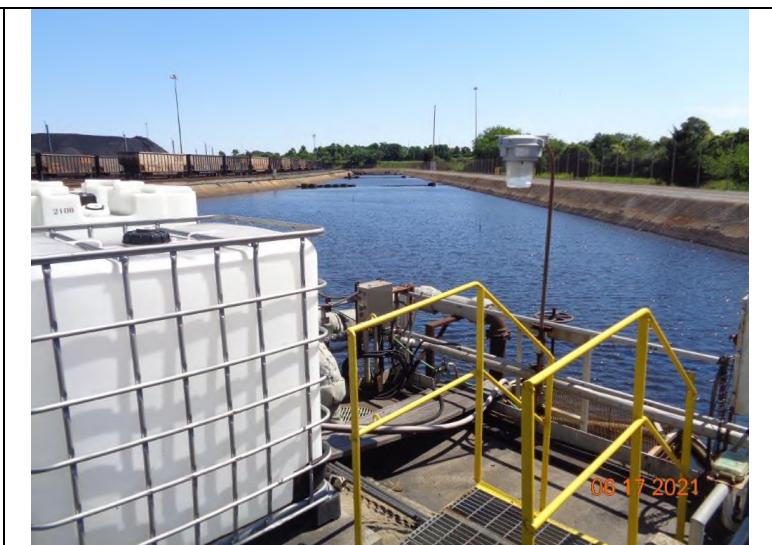
<p>7) Outfall 001 to the James River.</p>	<p>8) Pond 3, looking to the northeast. The containers have NaOH for neutralizing the pH.</p>

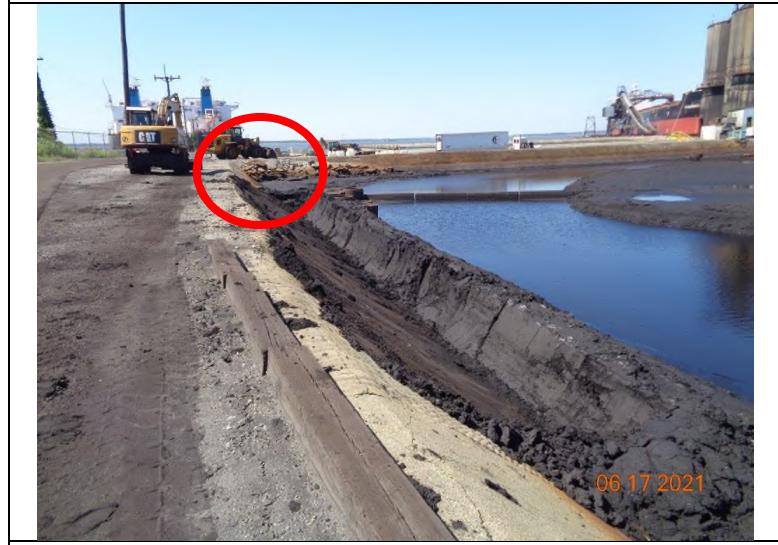
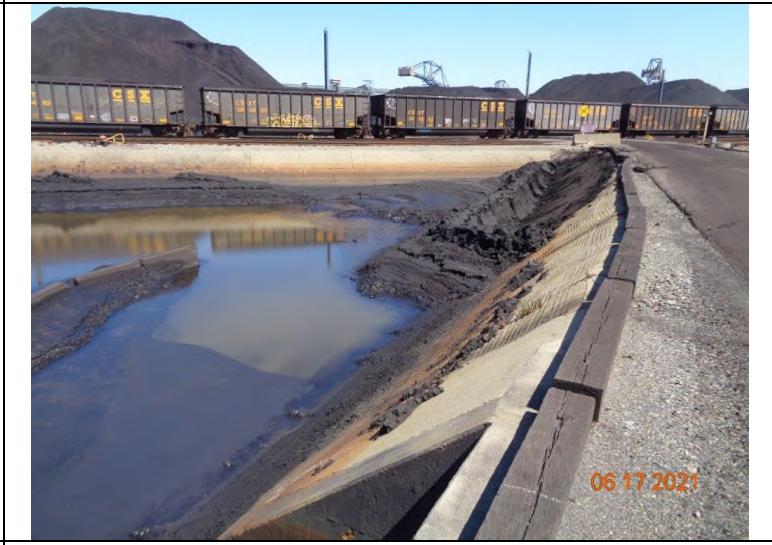
<p>9) View to the southwest showing Pond 1. A pipe, circled in red, was observed near the southeast corner of the pond. This conveyance is not shown on the site map. Coal fines have been pushed together for eventual collection.</p>	<p>10) View of Pond 1 looking to the north. The culvert connection between Ponds 1 and 3 is in the foreground.</p>

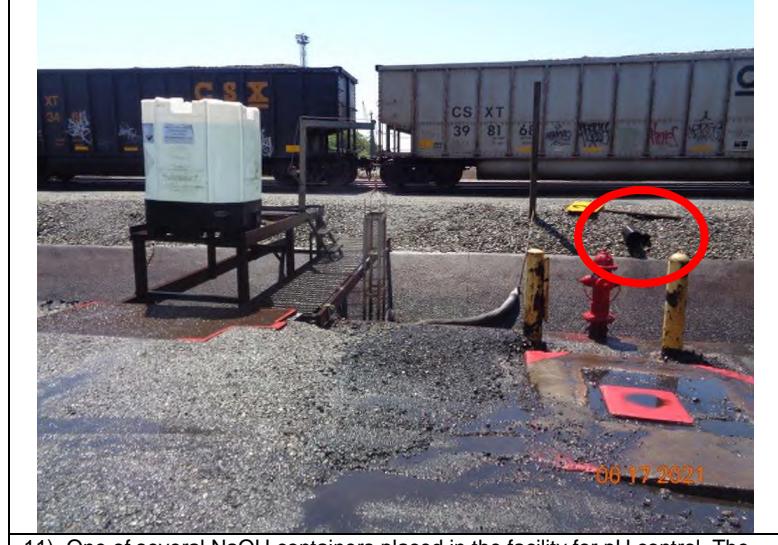
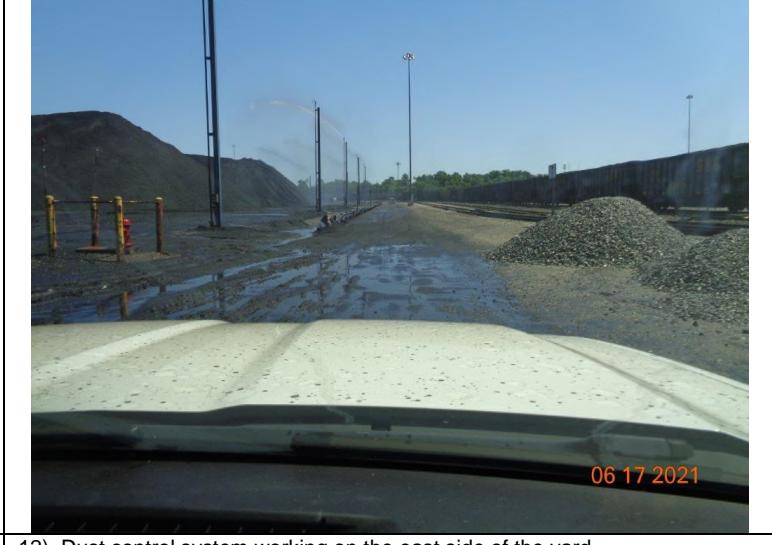
<p>11) One of several NaOH containers placed in the facility for pH control. The circle shows two pipes that are not shown on the map. Multiple pipes are located in the ditch line that are not shown on the map.</p>	<p>12) Dust control system working on the east side of the yard.</p>

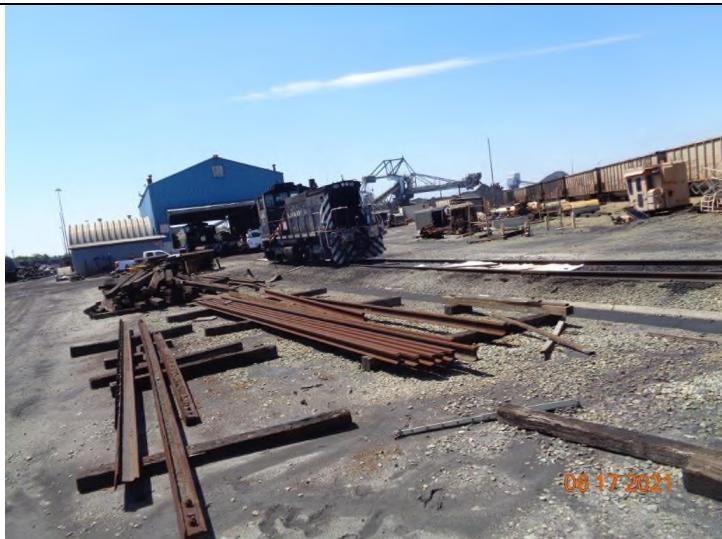
13) North maintenance area. The locomotive and the drip pads in the rail bed are also shown in photos 17-20. The maintenance building is in the background with covered storage and Quonset style building not on the map.

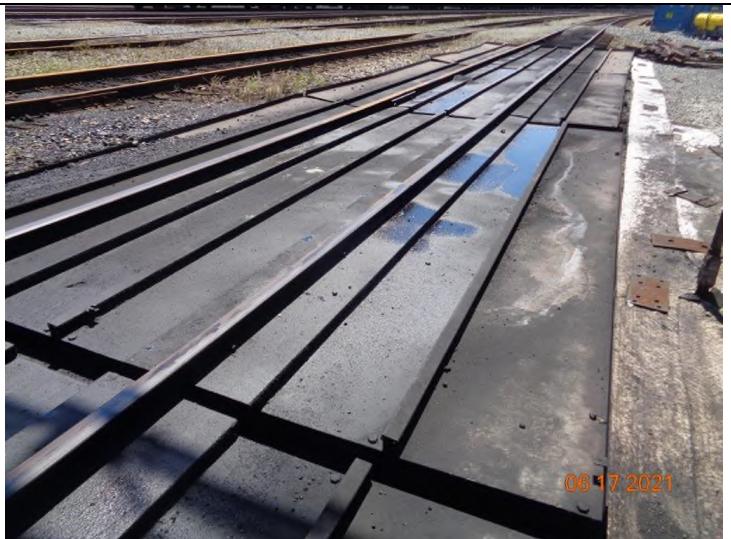
14) Railway spill pad system with spills observed. This discharges to an oil water separator. This is adjacent to CD-2 (containment dike) shown in the next 2 photos on the north end of the facility.

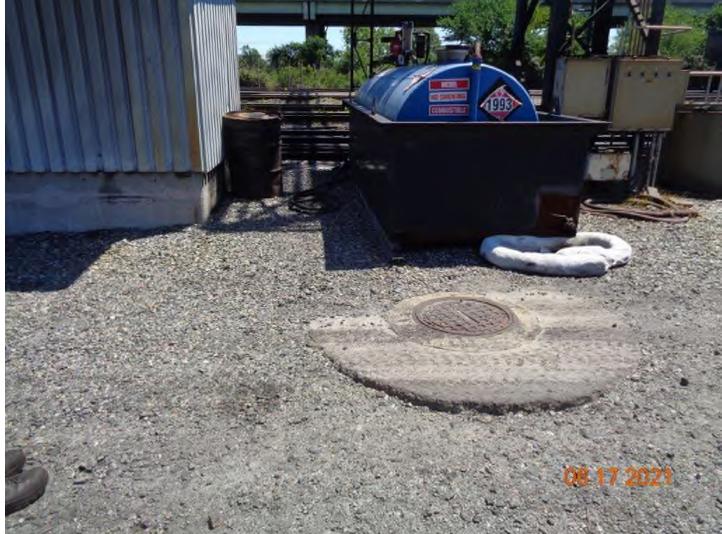
15) Oil water separator access. The blue building is CD-2 and contains ST (storage tank) -7. The storage tank shown above is ST-31. CD-2 is shown on the containment dikes map. ST-7 is not shown on either map.

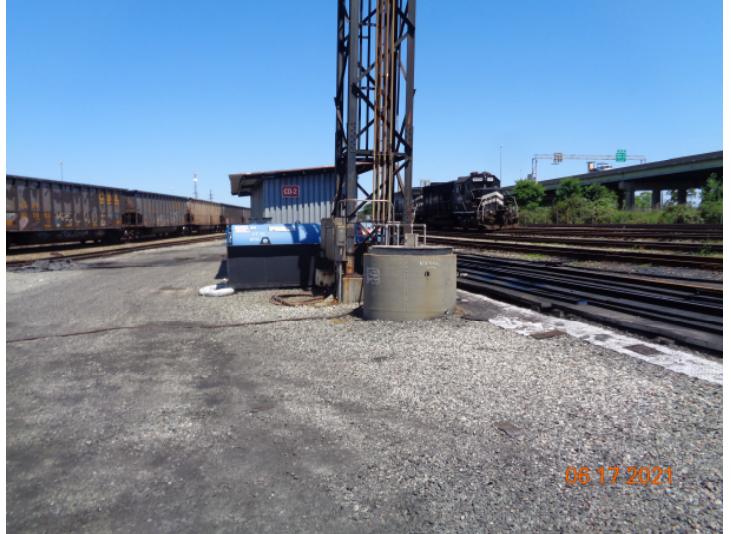
16) The building is CD 2 and the tank is ST 31. The spill pad shown in photo 14 is to the right. The iron support is the railcar dust suppression system that is not shown on the maps. The suppression system is shown in photo 18 too.

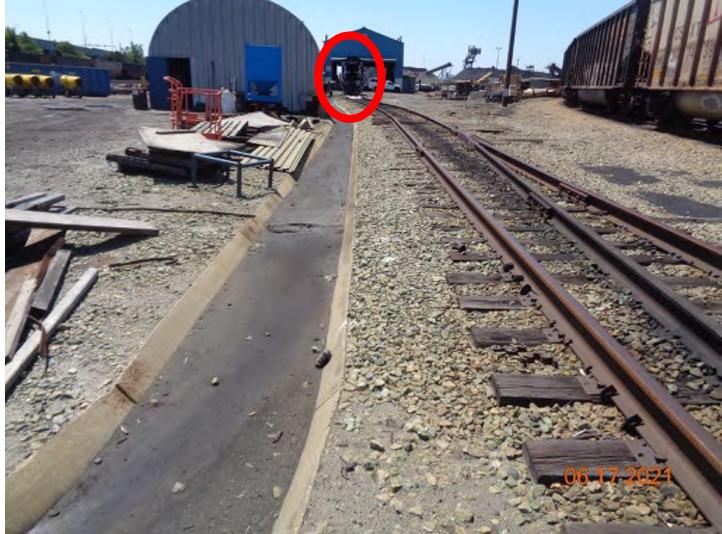
17) View to the south with the maintenance building in the background. The concrete swale and the Quonset style building are not shown on the map. This will connect to the main ditch system south of the maintenance building. The locomotive shown in 13 and 19-20 is circled.

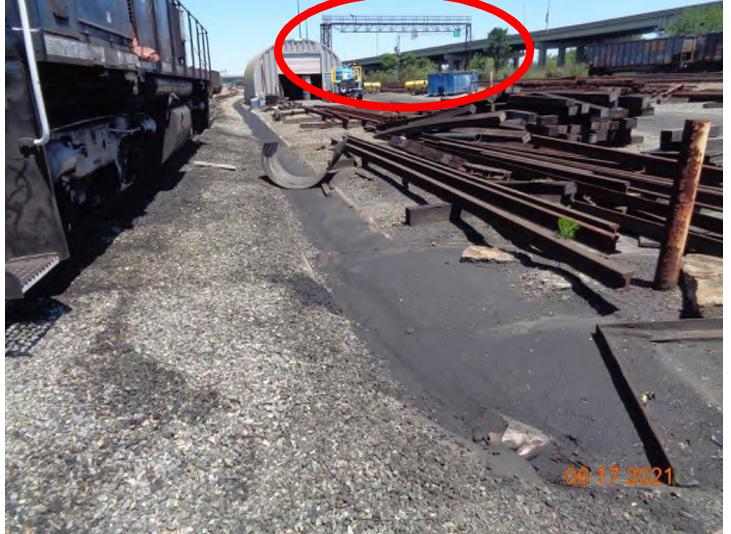
18) View to the north with the same Quonset style building shown in 17 and the locomotive just to the left. This is the continuation of the concrete swale shown in 17. The railcar dust suppression is circled.

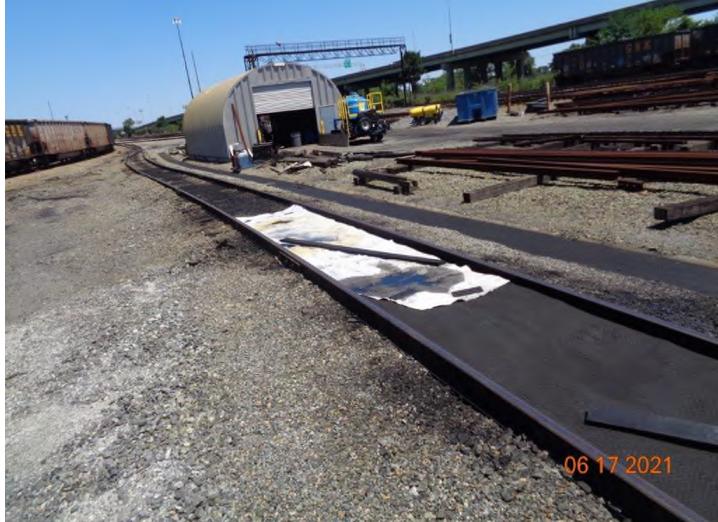
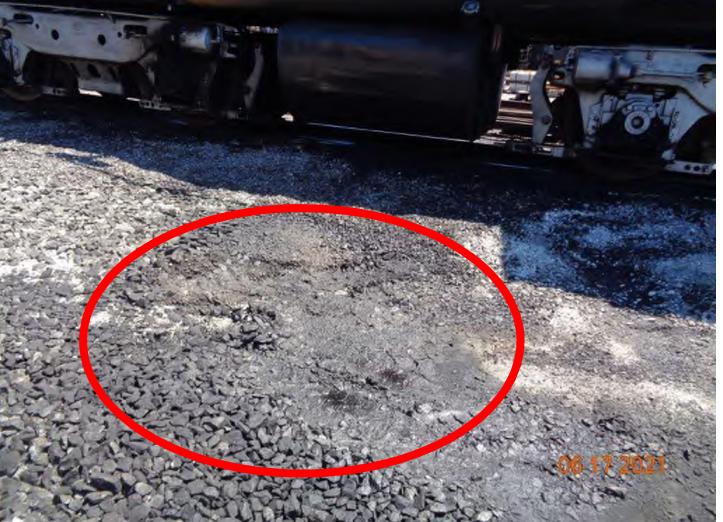
- Spillage was also observed near a locomotive near the maintenance building with free product on a spill pad. The liquid can be removed eliminating the exposure and will prevent runoff to the gravel in the areas. See photos 19 and 20.

<p>06 17 2021</p>
<p>19) Close up of the rail bed shown in photo 13 with oil on the white spill pads. The same Quonset building and concrete swale can also be seen.</p>	<p>20) The circle shows areas where oil has either been spilled or seeped through the ballast.</p>

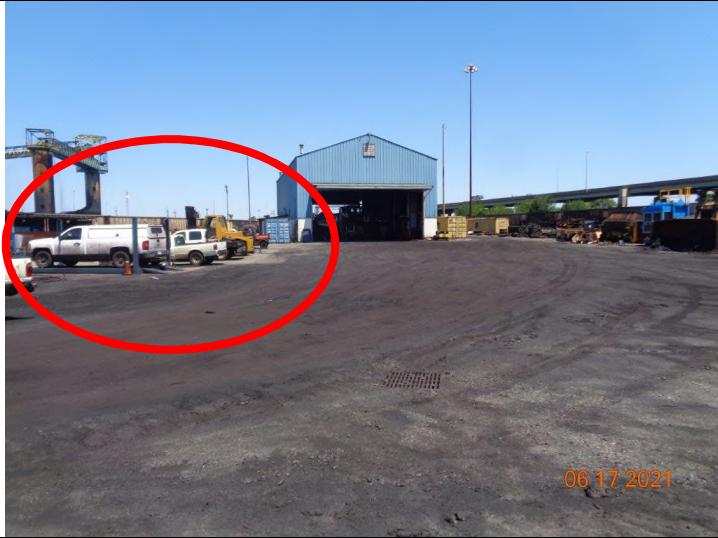
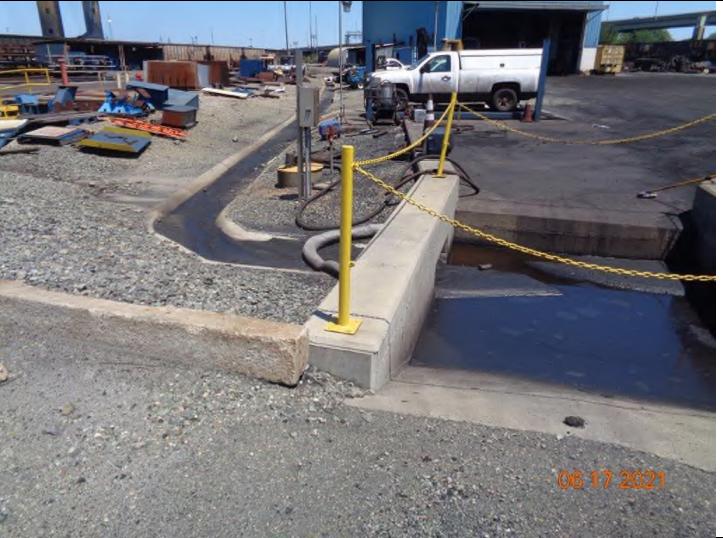
<p>06 17 2021</p>
<p>21) Maintenance building looking to the north. A drop inlet, included on the map is in the foreground. The area circled is a truck washing/rinsing area</p>	<p>22) End of the concrete swale that started near CD-2 covered storage (See photos 17-19) The same truck circled in photo 21 is shown in this photo with that area a wash/rinse location.</p>

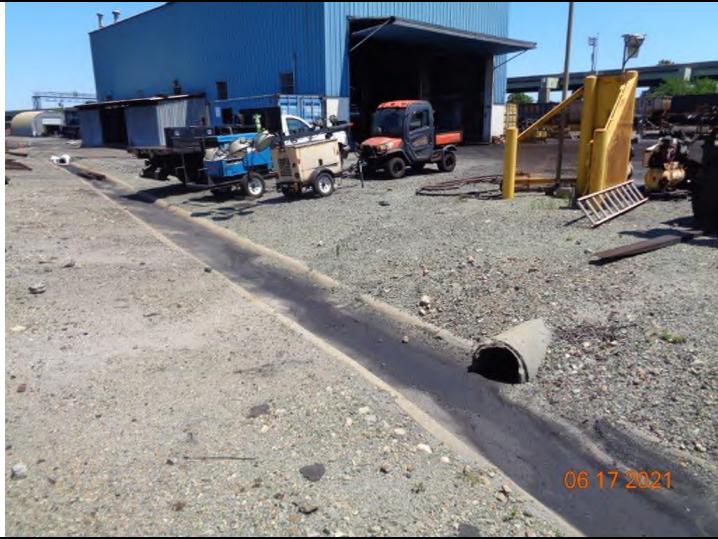
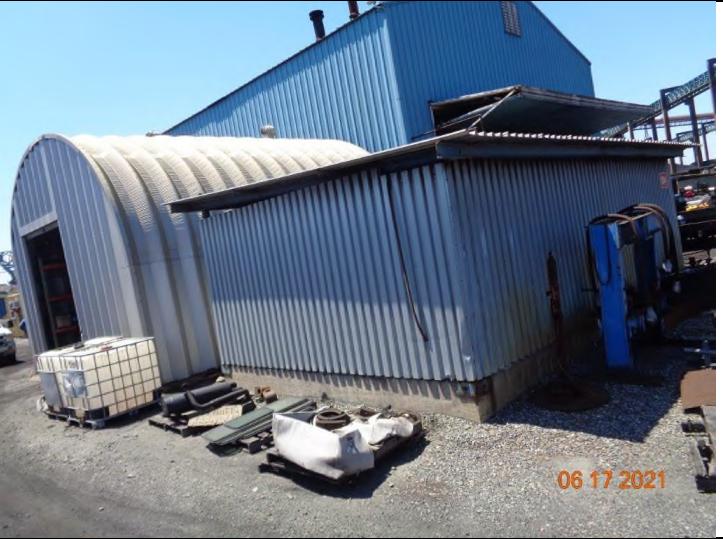
<p>06 17 2021</p>
<p>23) Maintenance building looking to the north. Concrete swale shown in 17-19 and 22 is in the foreground. An additional pipe from the northeast side of the building to the concrete swale is shown that is not included on the map.</p>	<p>24) North corner of the maintenance building with covered storage and Quonset building observed that is not on the site map.</p>
