Railroad Investigation Report: RIR-25-10

Norfolk Southern Railway Conductor Injury

Location	Norfolk, Virginia
Date	August 27, 2024
Accident type	Conductor injury
Train	Yard job UL30 1 engineer, 1 conductor 3 locomotives, 40 hopper cars
Track	Yard track
Hazardous materials	None
Fatalities	0
Injuries	1
Property Damage	None

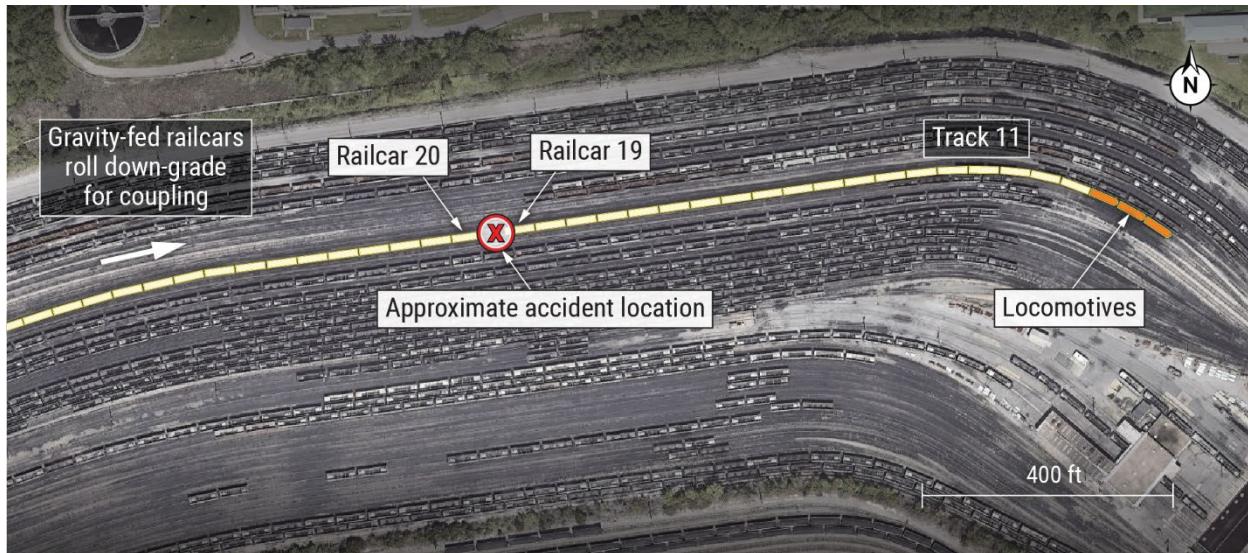
Figure 1. Accident scene. (Source: Google Earth.)

On August 27, 2024, about 10:10 p.m. local time, a Norfolk Southern Railway (NS) conductor was seriously injured while coupling coal railcars at the NS Empty Yard in Lambert's Point Yard in Norfolk, Virginia.¹ The conductor was part of a crew using locomotives to move railcars that had been gravity fed (rolled down-grade without a locomotive) into yard track 11. He made multiple attempts to couple railcar 19, the last railcar coupled to his train, to railcar 20 by directing the engineer in the lead locomotive to reverse short distances to bump the couplers together (see figure 1).² During the last of these attempts, the conductor radioed the engineer to reverse the train a quarter railcar-length, which bumped the railcars together and caused railcar 20 to roll up-grade.³ Eighteen seconds later, the conductor radioed the engineer to stop the train and apply three-step protection, which the engineer did.⁴ Less than a minute after the conductor asked for protection, railcar 20 rolled down-grade and struck him. He radioed

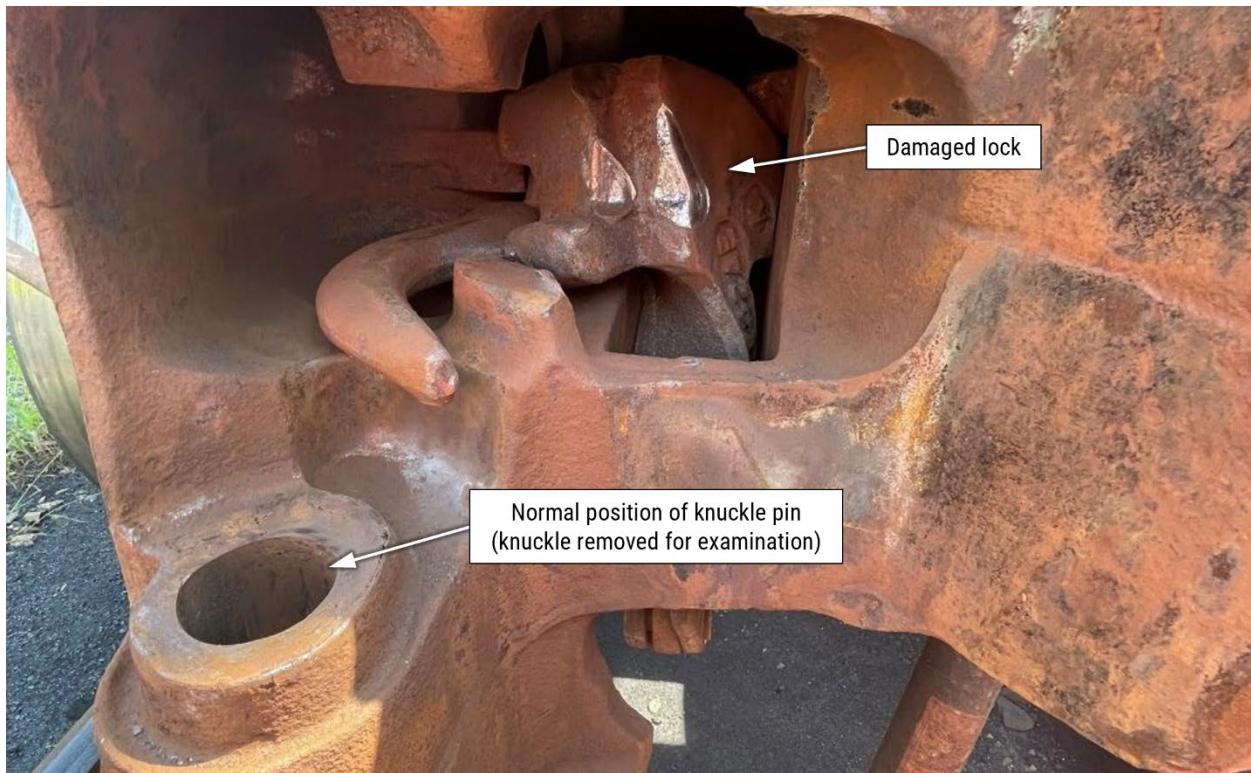
Figure 2. Damaged coupler.

The National Transportation Safety Board (NTSB) examined the coupler on railcar 19 and found that it was missing its coupler knuckle pin and that the lock was damaged, which prevented the knuckle from closing and coupling properly with railcar 20 (see figure 2). Railcar 19 underwent a mechanical inspection when it arrived in Lambert's Point Yard before the accident, which did not identify any defects. Between this inspection and the accident, the railcar was uncoupled from other hopper cars, gravity-fed to a coal dumper, and inverted-flipped upside down by the dumper—to unload its contents before being gravity rolled into the yard track where the accident occurred. No attempts were made to couple the railcar between its arrival and positioning on yard track 11.

⁶ During the on-scene investigation, the NTSB removed the inoperable knuckle from the coupler on railcar 19 after determining that it could not close.

The conductor was probably positioned between railcars because he was struggling to adjust one or more couplers to join railcars 19 and 20. The NTSB's examination of the involved railcars showed that coupling these railcars was impossible because of a damaged coupler on railcar 19. Specifically, the coupler was missing a knuckle pin, and the deformation of the coupler lock was consistent with a coupling attempt exceeding the knuckle's intended range of motion, which is normally limited by the pin. If the knuckle pin was in place when the railcar arrived at Lambert's Point Yard, it likely fell out when the railcar was inverted by the dumper. Normally, this is prevented by a cotter pin that holds the knuckle pin in position. The last mechanical inspection performed on railcar 19 did not note any defects—such as a missing cotter pin—but the absence of alternative explanations suggests that the inspection failed to identify either a missing knuckle pin or a missing cotter pin.

Although the accident occurred because of unsecured equipment, the accident sequence began with an inspection that failed to identify a missing knuckle pin. After the accident, NS re-affirmed during pre-shift meetings with yard employees the importance of replacing missing knuckle pins during inspections, properly securing knuckle pins, and, if the pins cannot be replaced or secured, removing the affected railcars from service until they can be repaired.
