Re: Technical Inspection Report (VA0057576)

Facility:	DOMINION TERMINAL ASSOCIATES
County/city:	NEWPORT NEWS

**DEPARTMENT OF ENVIRONMENTAL QUALITY  
WASTEWATER FACILITY  
INSPECTION REPORT  
PART 1**

Inspection date:	September 7, 2011	Date form completed:	September 9, 2011
Inspection by:	Mark R. Kidd	Inspection agency:	DEQ/TRO
Time spent:	6 hours	Announced Inspection:	[ ] Yes [✓] No
Reviewed by: Kenneth T. Raum / 09-29-11 <i>KTR</i>		Photographs taken at site?	[✓] Yes [ ] No
Present at inspection:	Dan Wagoner, Wesley Simon-Parsons

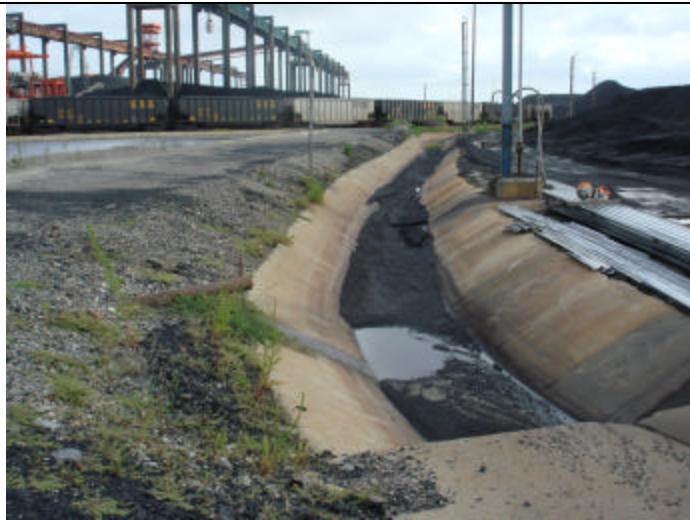
<p>I conducted a site survey with the assistance of Mr. Simon-Parsons. Except for the waterfront the facility is encircled by a concrete ditch system (Photos 1&amp;2) that drains to 3 storm water retention ponds. Storm water from the waterfront flows by gravity to collection points where storm water is transported to the ponds. Several sodium hydroxide injection points are maintained along the ditch system (Photos 3&amp;4) and at the pond effluent points for pH adjustment. Secondary containment structures for drum storage (Photo 5) and waste oil (Photo 6) appeared in need of cleaning. Mr. Simon-Parsons stated that secondary containment cleaning was scheduled for the following week. Several rusting metal containers were observed exposed to storm water (Photo 7). A vehicle wash (Photo 8) uses only water and the discharge flows to the storm water pond. All three of the ponds (Photos 9-12) appeared well maintained with low accumulation of solids and adequate freeboard. Planned discharges from Pond #2 are initiated in anticipation of wet weather to maintain proper freeboard. The water</p>

Photo 1. Concrete ditch.

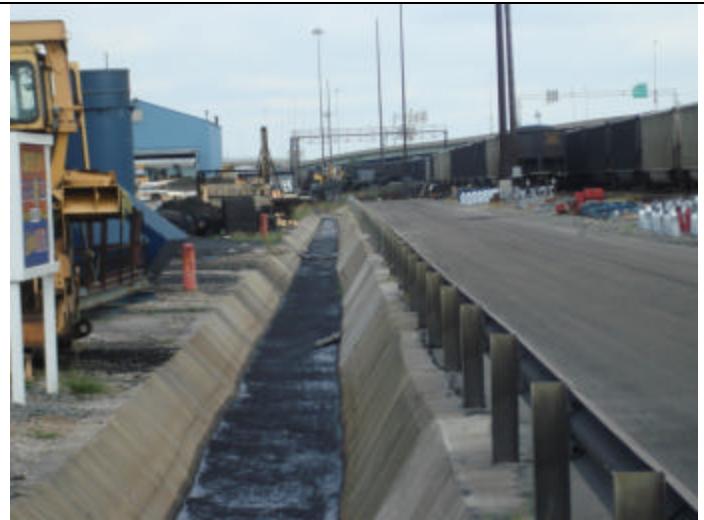
Photo 2. Another view of the concrete ditch.

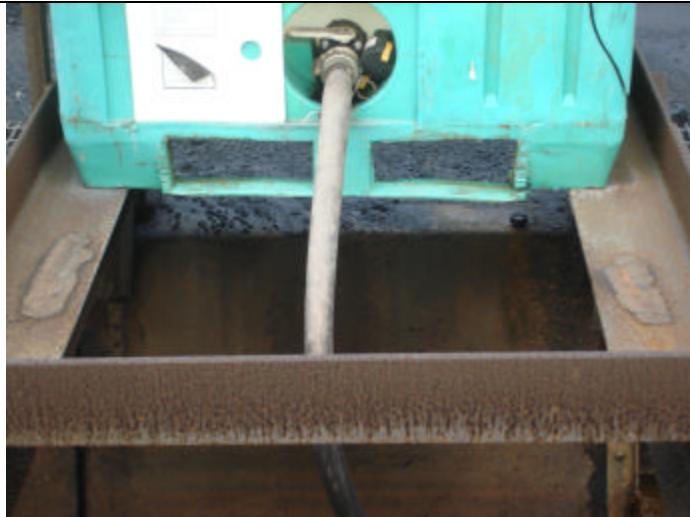
Photo 3. pH adjustment structure.

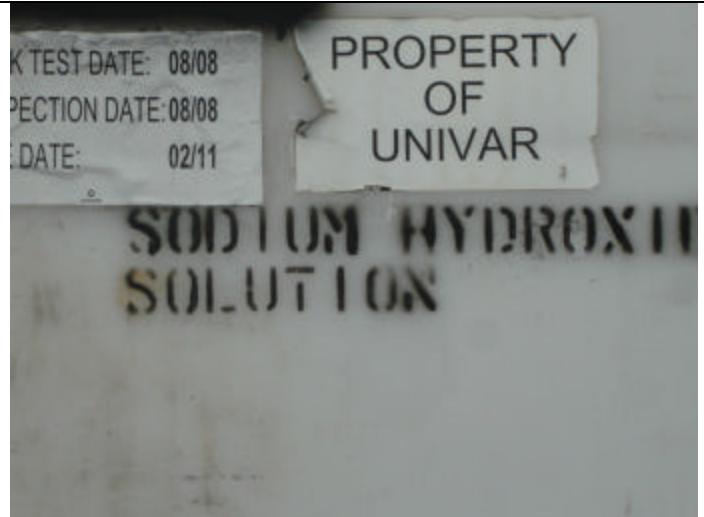
Photo 4. Sodium Hydroxide for pH adjustment.

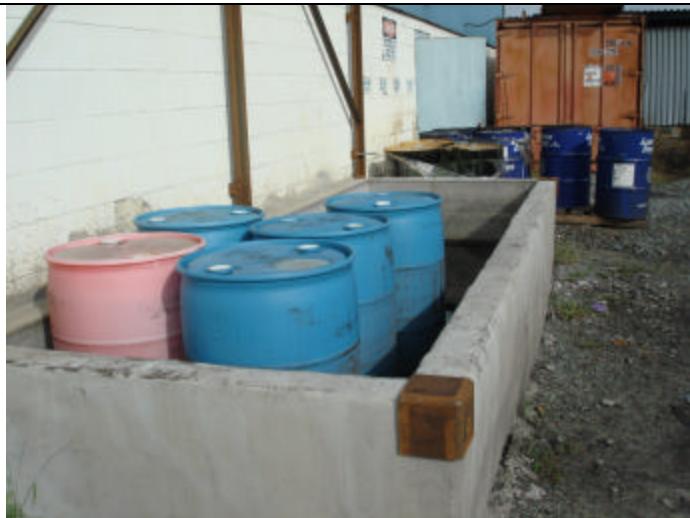
Photo 5. Drum storage.

<b>Maintain a log book of freeboard measurements.</b>
	<b>Clean secondary containment structures.</b>
	<b>Remove the rusting metal containers from storm water exposure.</b>

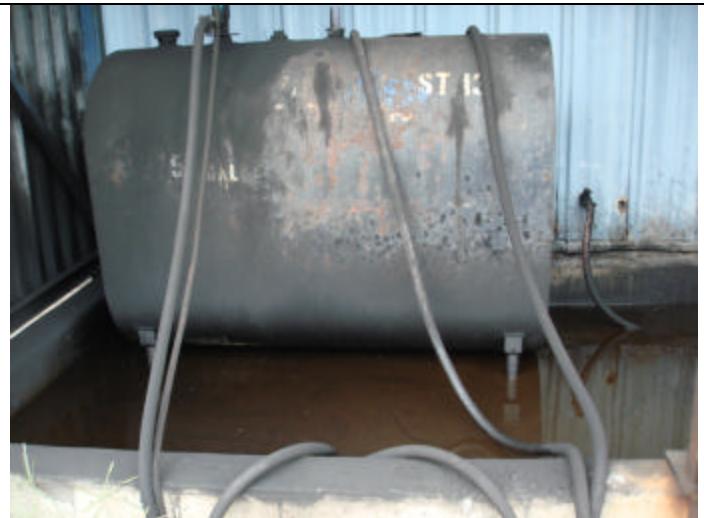
Photo 6. Waste oil containment.

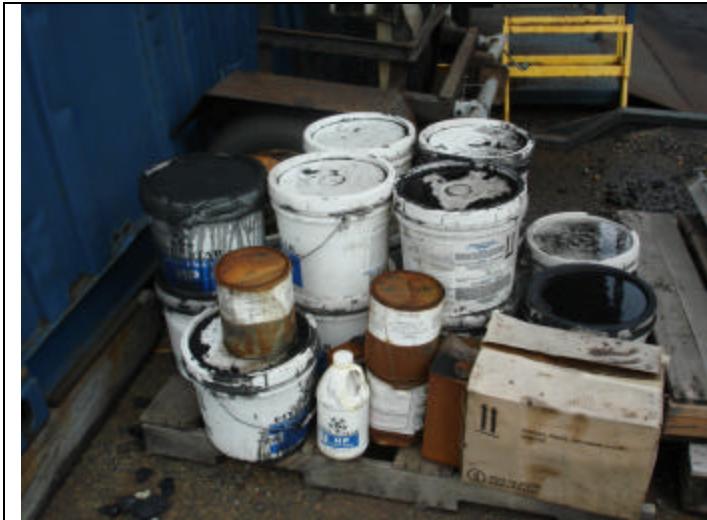
**Photo 7. Rusty containers.**

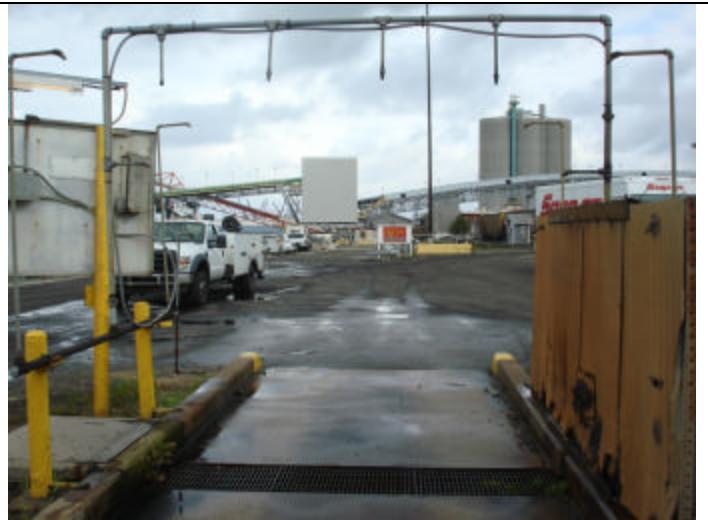
**Photo 8. Vehicle wash.**

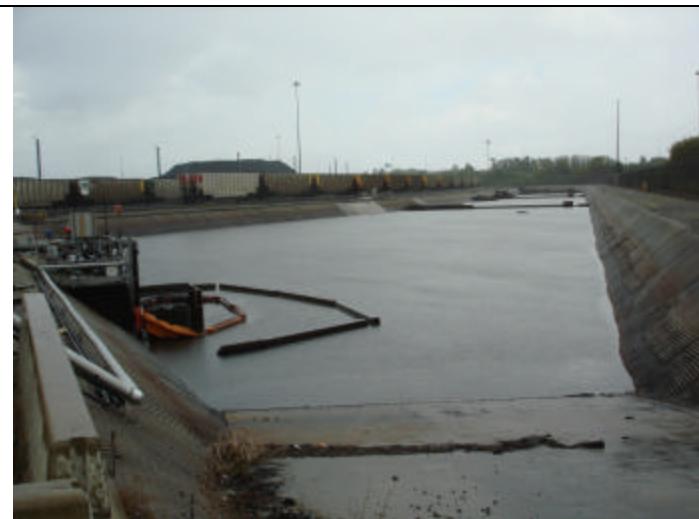
**Photo 9. Pond 3.**

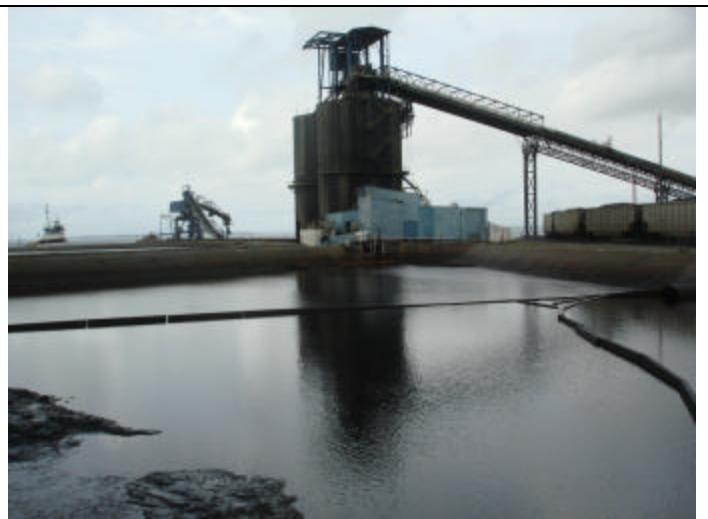
**Photo 10. Pond 1.**

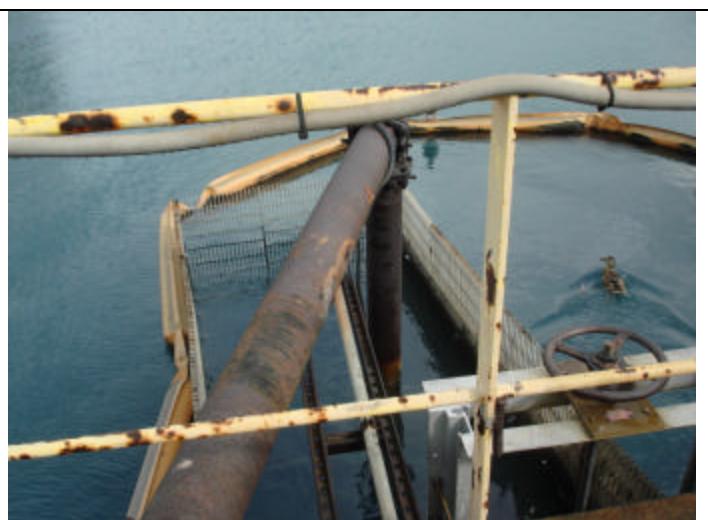
<b>level is maintained so that enough water for use in the dust control system is available without having to use groundwater.</b>
--	--

**Photo 12. Pond 2 discharge structure.**
