Dominion Terminal Associates LLP

August 17, 2021

Attention: Mr. Steven J. E. Long
Re: June 17, 2021, Inspection on VPDES Permit #VA0057576

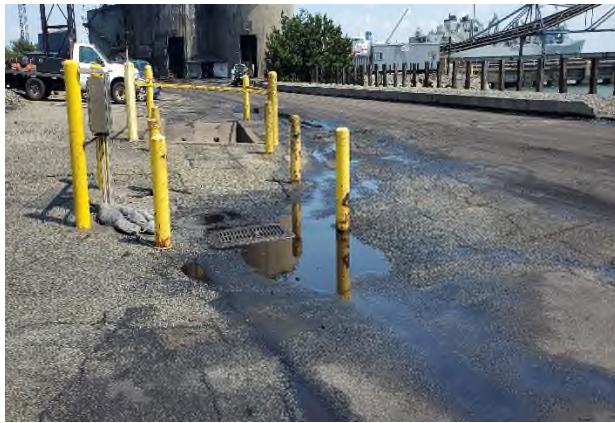
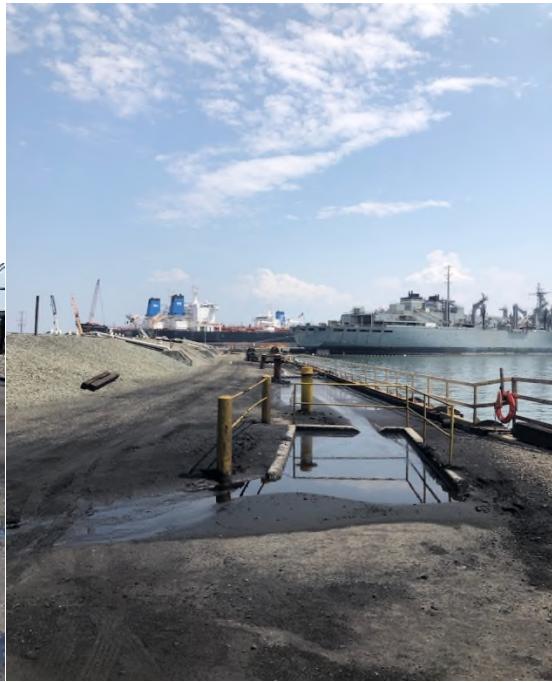
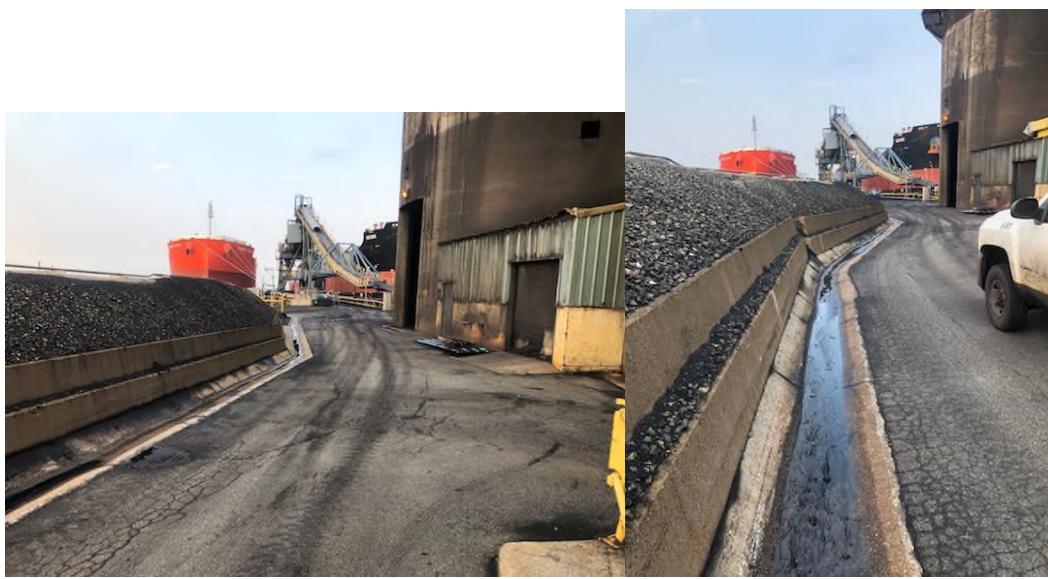
and oil spills and stains observed. See photos 2-4, 14, 17-20 for some examples of areas needing cleanup.

The above pictures reference (Swales needing cleaning), your pictures #2, 3 & 4 correspond with our pictures showing the issues remediated.

- We cleaned out the coal fines in the swales. (see attached pictures)
- The oil spills were remediated. (see attached pictures)
- The north maintenance area did have spills that should be cleaned up. A railway spill pad had some spillage on the pad that could be cleaned up and prevented from reaching the oil water separator associated with the pad. Cleaning eliminates the entrainment of the oil in the stormwater and will extend the time for cleanout of the separator. See photos 14-16.

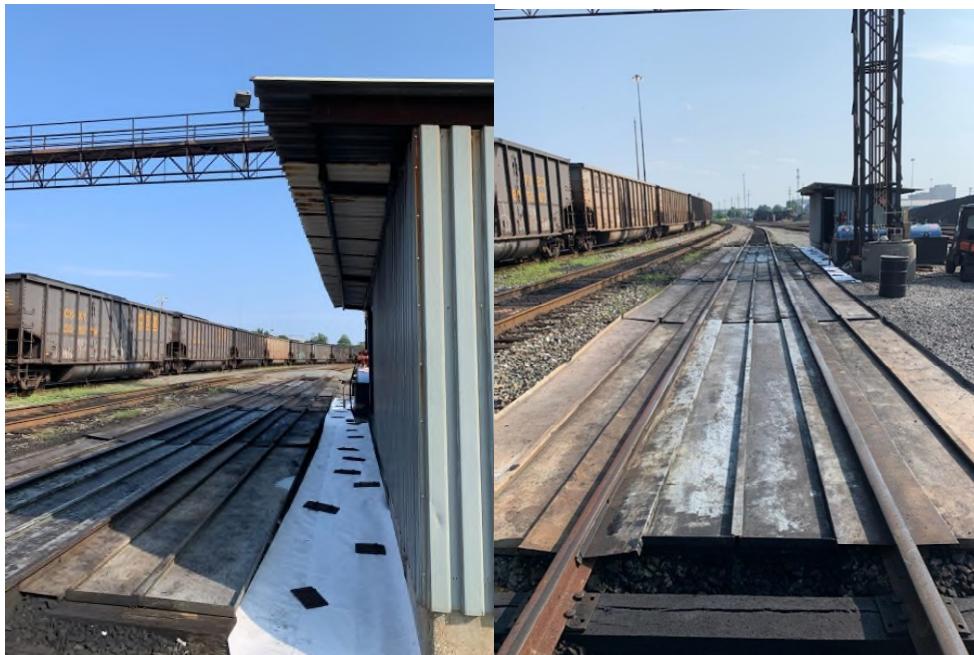
The above pictures reference (Railway spill pad system), your picture #14 corresponds with our pictures showing the issue remediated.

- We cleaned the spill pan and surrounding area. (see attached pictures)
- Spillage was also observed near a locomotive near the maintenance building with free product on a spill pad. The liquid can be removed eliminating the exposure and will prevent runoff to the gravel in the areas. See photos 19 and 20.

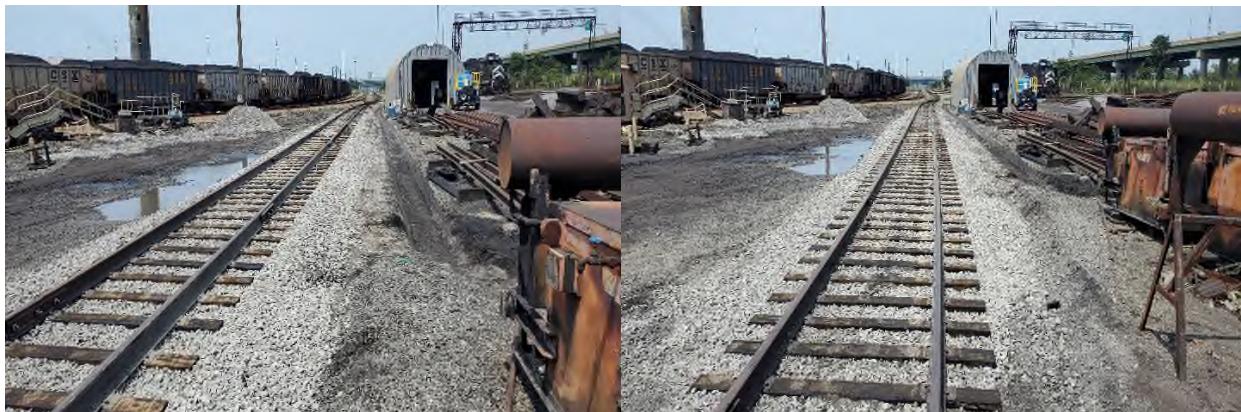
The above pictures reference (Locomotive Service Track), your pictures #19 & #20 correspond with our pictures showing the issue remediated.

- The Service Track oil spill was remediated. (see attached pictures)
- Multiple conveyances and buildings were observed at the facility that are not shown on the site map. See photos 1-5, 9, 1117-19, 22 and 23. All conveyances and structures are to be shown on the site map. See below for map requirements and citations.

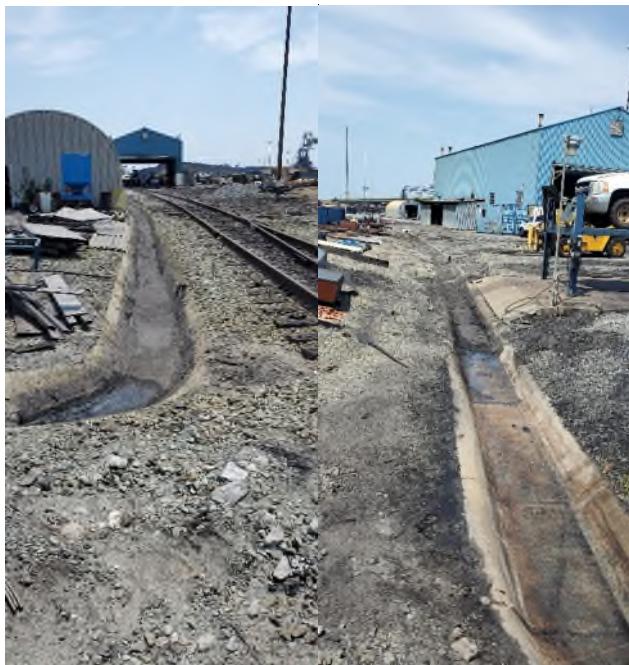
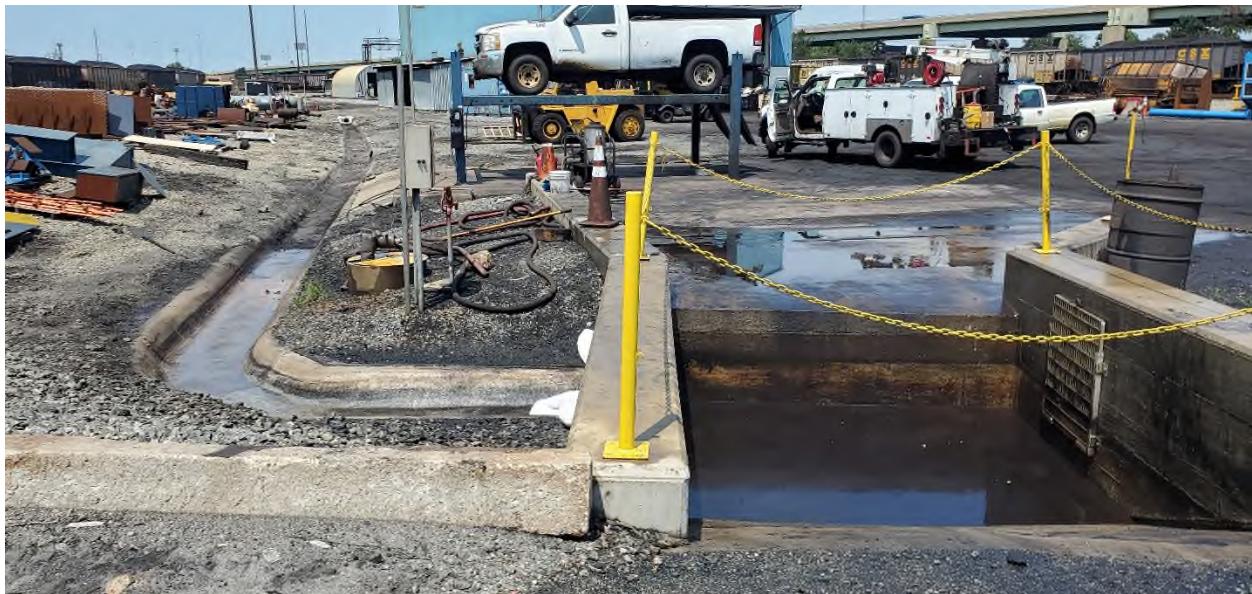
The above pictures reference (Swales needing cleaning), your pictures #17, 22 & 23 correspond with our pictures showing the issues remediated.
