Re: Technical and Laboratory Inspection Reports, VA0057142

Facility:	KINDER MORGAN PIER IX
County/city:	NEWPORT NEWS, VA

VPDES NO. **VA0057142**

DEPARTMENT OF ENVIRONMENTAL QUALITY
WASTEWATER FACILITY
INSPECTION REPORT
PART 1

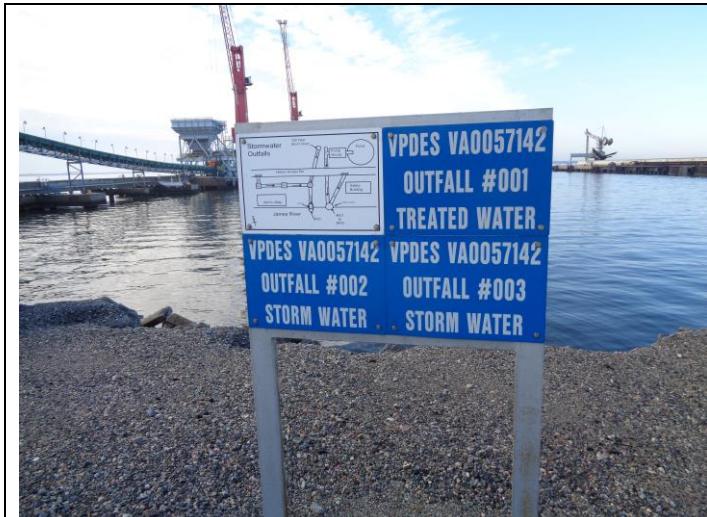
A site inspection was conducted with the assistance of Mr. Hill and Mr. Lieberman. A sign is posted at the facility's outfall location (Photo 1). A drop inlet (Photos 3 and 4) in front of the Safety and Training building, which is blocked with a steel plate, would otherwise discharge to Outfall 003. The water that would drain to the curb inlet flows to a storage vault and is then pumped to the perimeter ditch. A sampling location for Outfalls 001 and 002 is protected and provides access to two separate discharge pipes for sampling (Photo 2). Outfall 001 is a pumped discharge from the retention pond (Photo 6). Water from the perimeter ditch formerly flowed by gravity into the retention pond but this flow is blocked by a gate valve. The water from the perimeter ditch is pumped from the perimeter ditch to the pond (circled in Photo 6) through a ductile iron pipe. The water from the pond outlet flows to a pump room and is then pumped to Outfall 001. The east side of the perimeter ditch is built of concrete. Rainbirds that use water from the retention pond for dust management were not in operation during the inspection. Water from the coal railcar dump station collects in a sump before being pumped to the ditch system. Water from the pier collects in a sump before being pumped to the retention pond (Photo 5).

Photo 1. Sign adjacent to outfall locations showing conveyance set up and drainage areas.

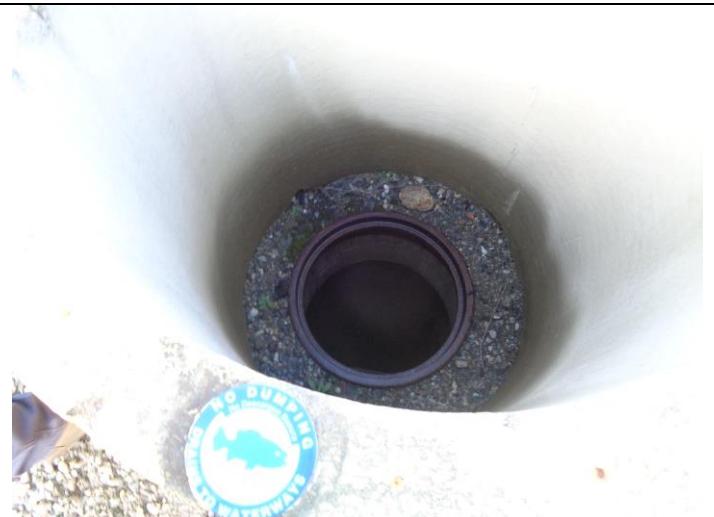
Photo 2. Sampling point for Outfall 001.

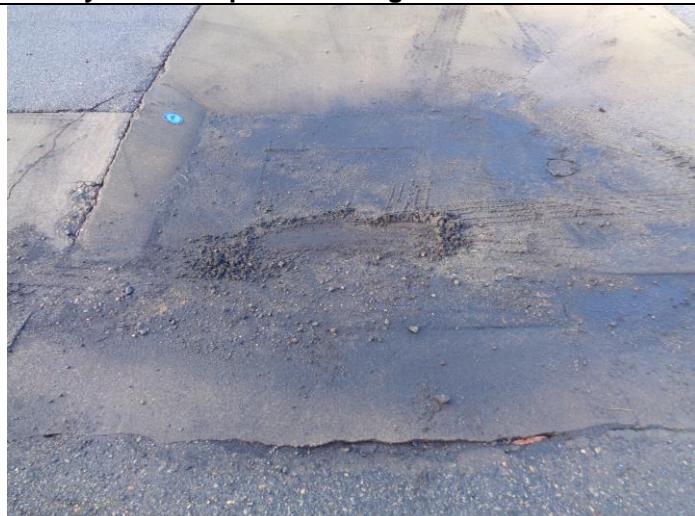
Photo 3. Buildup of solids overtop of covered Outfall 003 drop inlet.

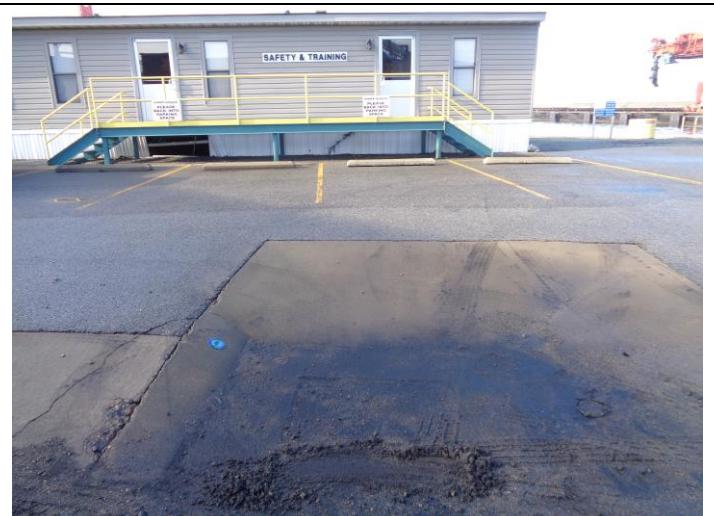
Photo 4. Another view of steel plate covering Outfall 003 drop inlet.

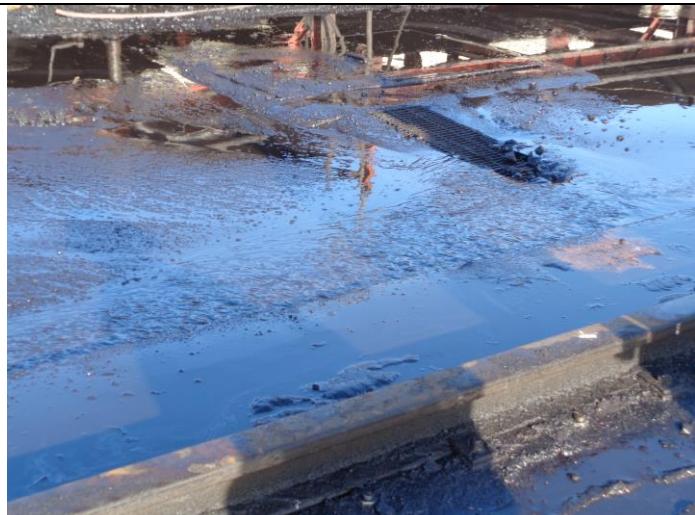
Photo 5. Pier water entering drop inlet to be pumped to pond.

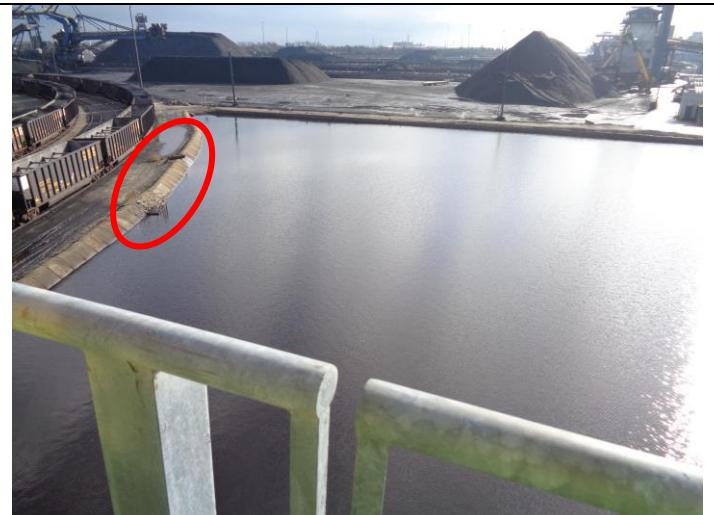
Photo 6. View from above the retention pond. Ditch line discharge point into pond is circled in red.
