Re: Laboratory and Technical Inspection Reports
Kinder Morgan Pier IX (VA0057142)

Facility:	KINDER MORGAN PIER IX
County/city:	NEWPORT NEWS, VA

VPDES NO.	VA0057142
-----------	------------------

**DEPARTMENT OF ENVIRONMENTAL QUALITY
WASTEWATER FACILITY
INSPECTION REPORT
PART 1**

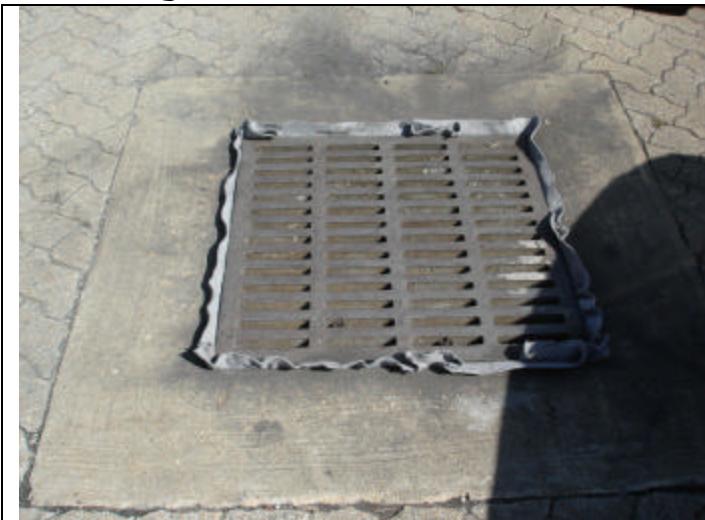
<p>A site survey was conducted with the assistance of Mr. Steil and Mr. Lester. The drop inlets in front of the administration building (Photo 1) use a filter cloth and discharge via Outfall 003 (Photo 4). A curb inlet (Photo 2), which is blocked with a steel plate, would otherwise discharge to Outfall 003. The water that would drain to the curb inlet flows to a storage vault and is then pumped to the perimeter ditch. A sign is posted at the facility's outfall location (Photo 3). A sampling location for Outfalls 001 and 002 is protected and provides access to two separate discharge pipes for sampling (Photo 5). Another curb inlet that discharges to Outfall 002 is blocked in the same way as seen in Photo 2. Outfall 001 is a pumped discharge from the retention pond (Photo 6). Water from the perimeter ditch formerly flowed by gravity into the retention pond but this flow is now blocked by a gate valve (Photo 7). The water from the perimeter ditch is now pumped from the perimeter ditch to the pond (Photo 11) through a ductile iron pipe (Photo 8). The water from the pond outlet (Photo 9) flows to the pump room (Photo 10) and is then pumped to Outfall 001. The east side of the perimeter ditch is now built of concrete (Photo 12) with oil booms placed at all cross over structures (Photo 13). Rainbirds were in operation during the</p>

Photo 1. Drop inlet with filter cloth.

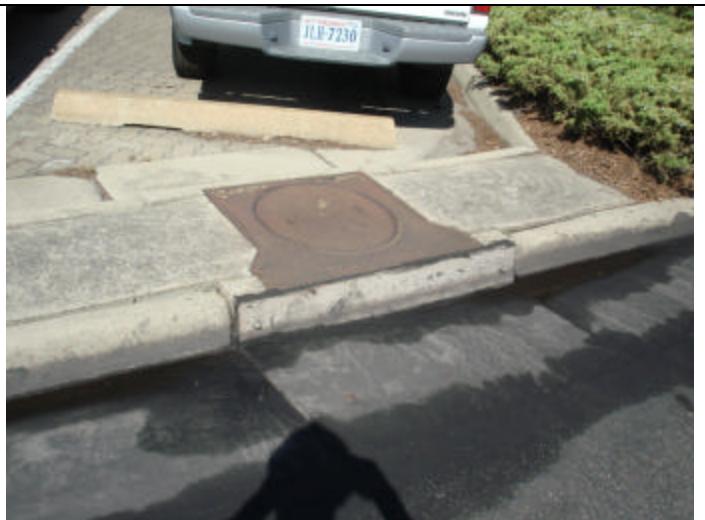
Photo 2. Curb inlet blocked off.

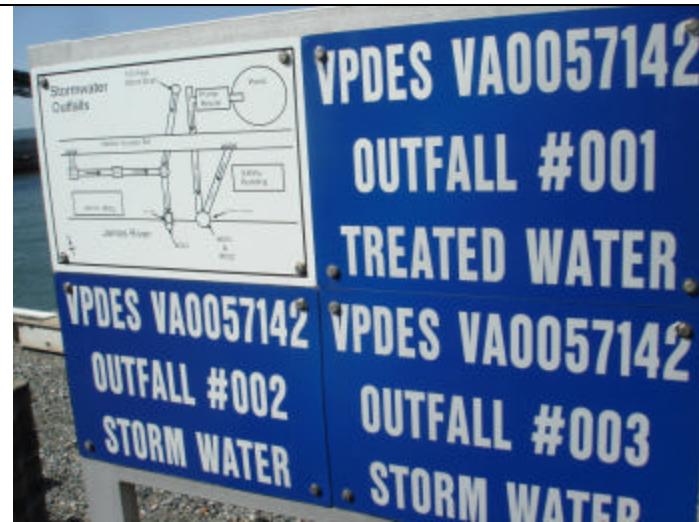
Photo 3. Sign at discharge location.

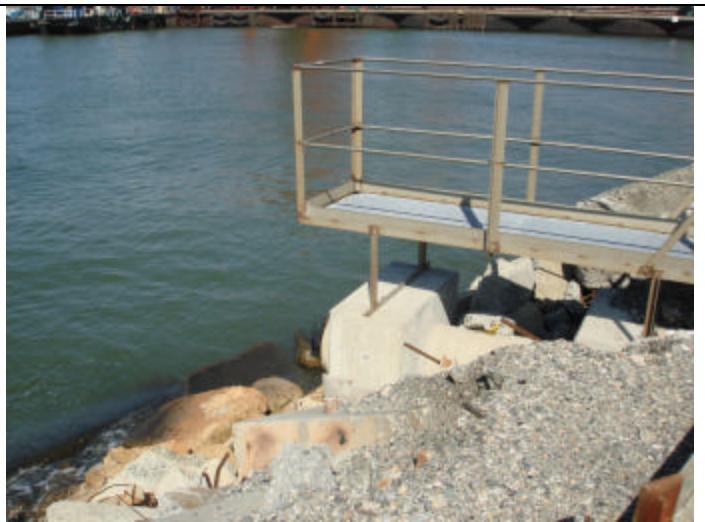
Photo 4. Outfall 003 discharge point.

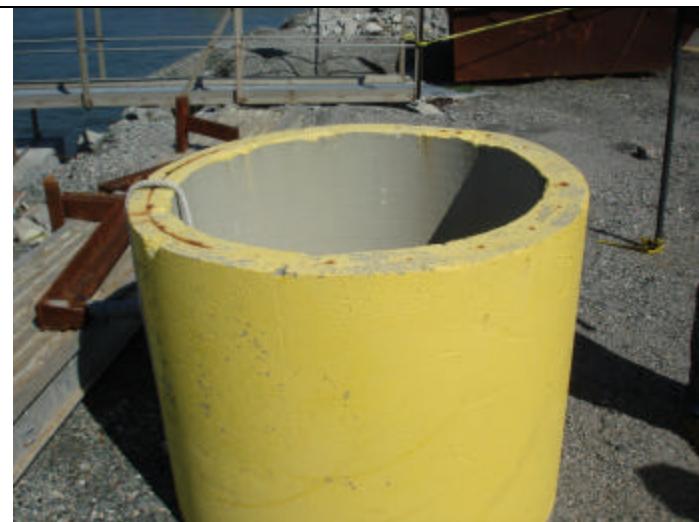
Photo 5. Sample point for Outfalls 002 and 001.

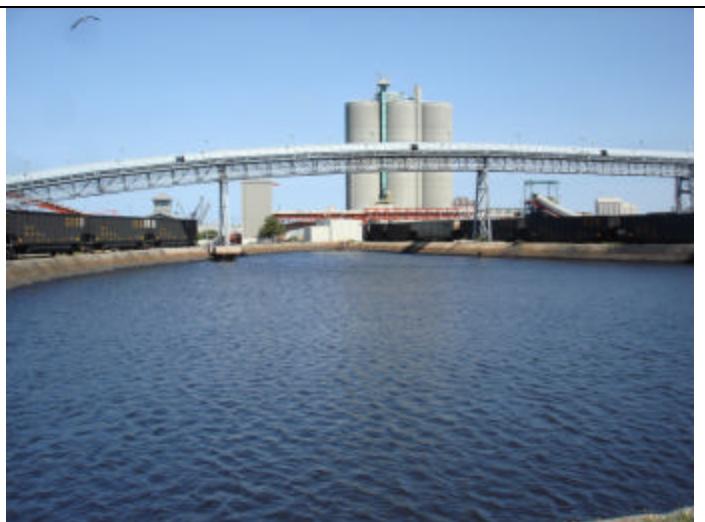
Photo 6. Retention pond.

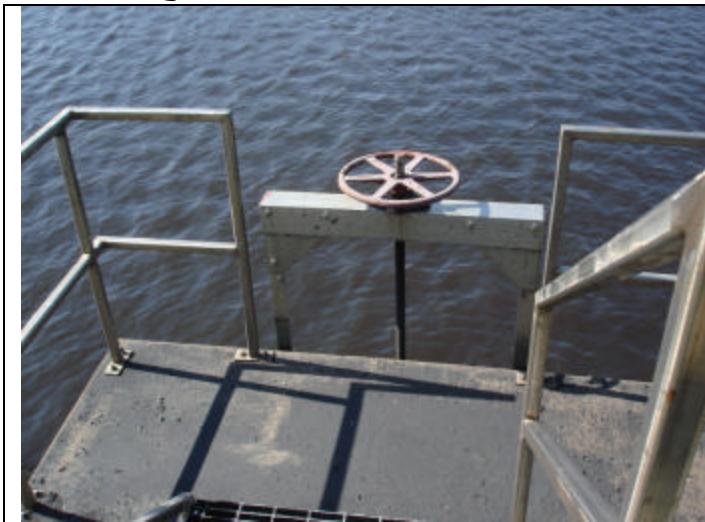
Photo 7. Gate for gravity flow from perimeter ditch to the retention pond.

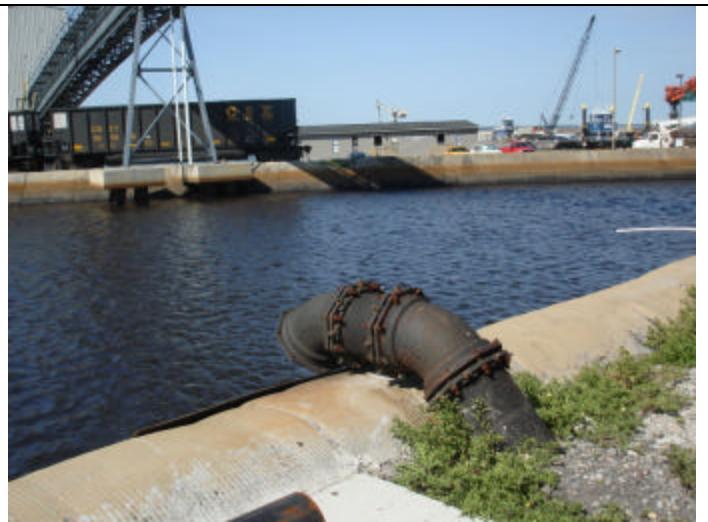
Photo 8. Discharge pipe for pumped discharges from perimeter ditch to the retention pond.

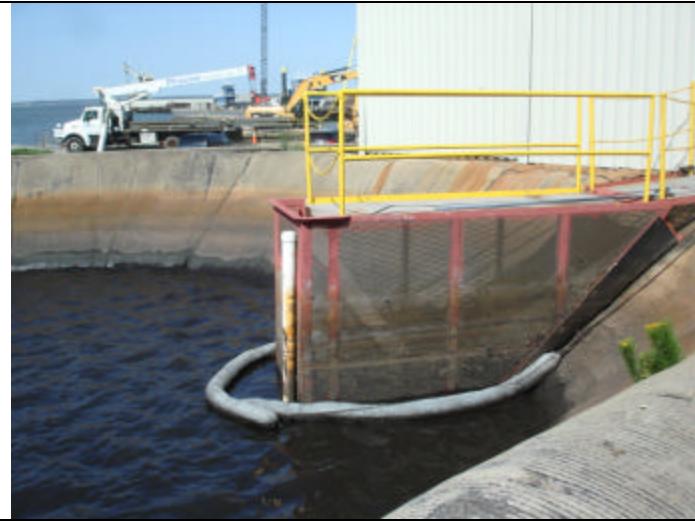
Photo 9. Pond outlet structure.

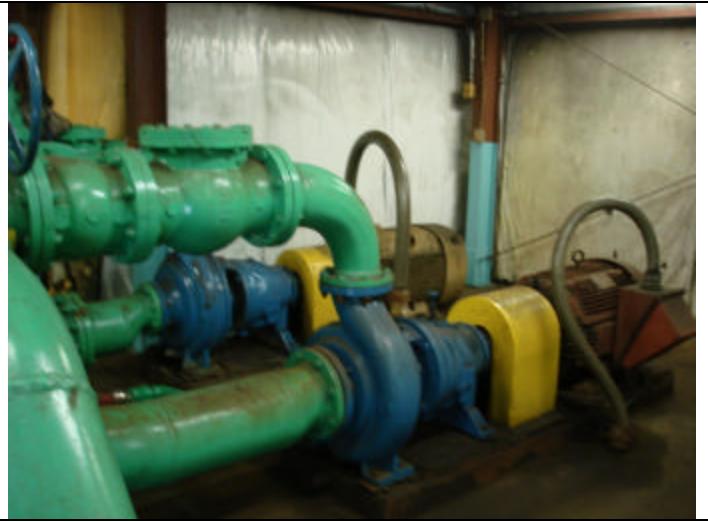
Photo 10. Discharge pump and rainbird pump.

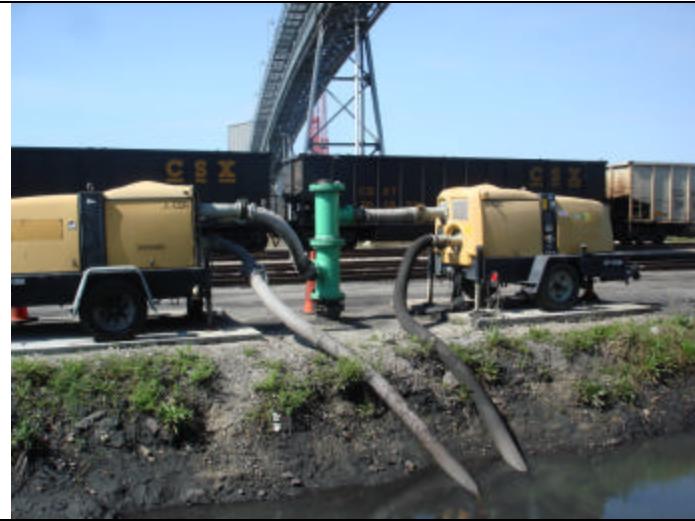
Photo 11. Pumps for transporting ditch water to the retention pond.

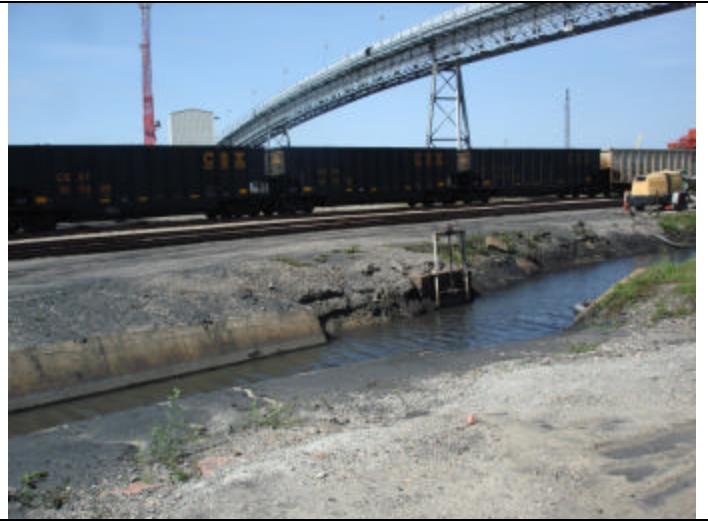
Photo 12. Perimeter ditch.

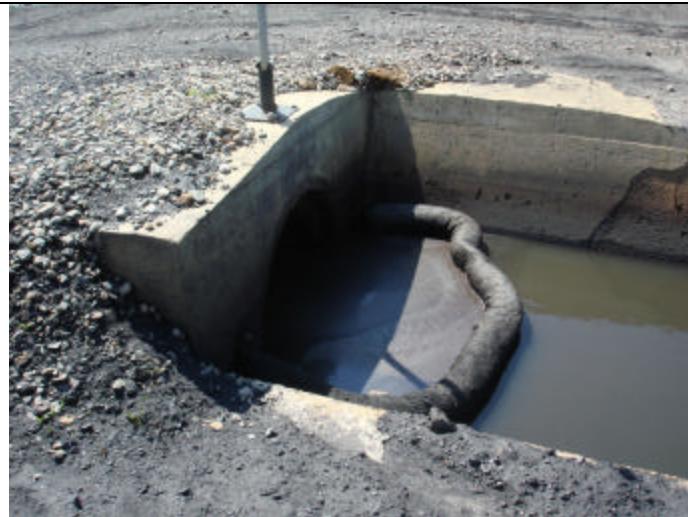
Photo 13. Oil boom in perimeter ditch.

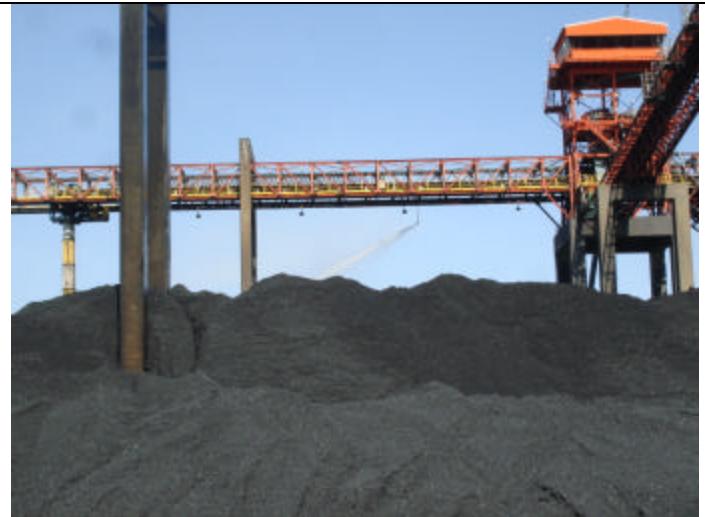
<p>inspection (Photo 14) using water from the retention pond. The coal transport belt structure is covered while being painted (Photo 15). Water from the coal railcar dump station (Photo 16) collects in a sump before being pumped to the ditch system. Spill kits (Photo 17) include oil absorbent pads and booms. The fuel pad (Photo 18) appeared clean and free of stains.</p> <p>Overall the facility appeared well managed and displayed good housekeeping practices.</p>
	I would like to thank Mr. Steil, Mr. Lester and Mr. Shirk for their assistance and cooperation during the inspection.
	COMPLIANCE RECOMMENDATIONS FOR ACTION:
	None at this time.

Photo 14. Rain birds in use.

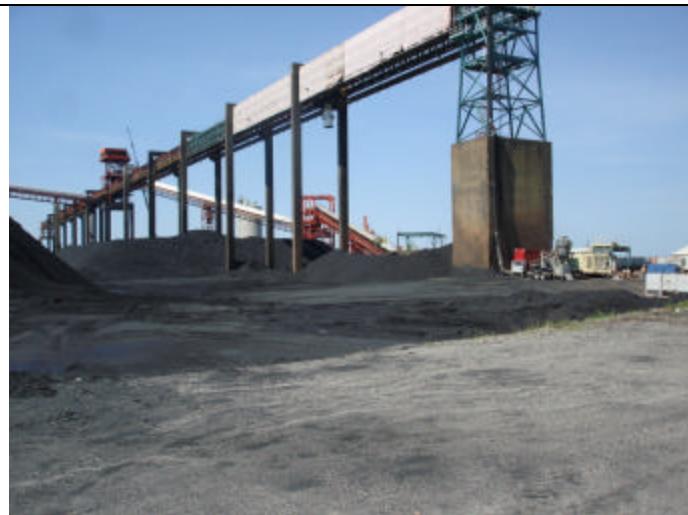
Photo 15. Transport belt structure with covers while being painted.

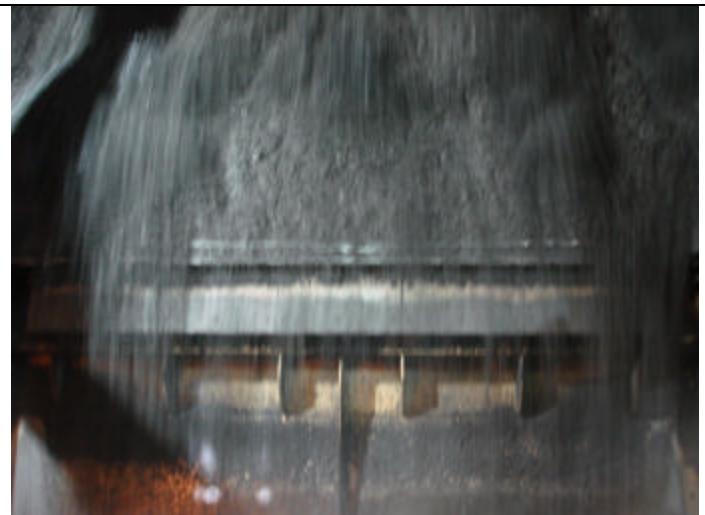
Photo 16. Coal being dumped from railcar.

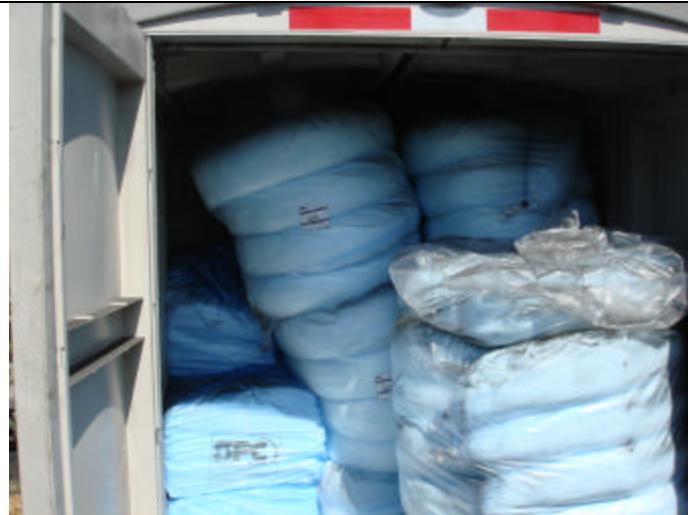
Photo 17. Spill kit.

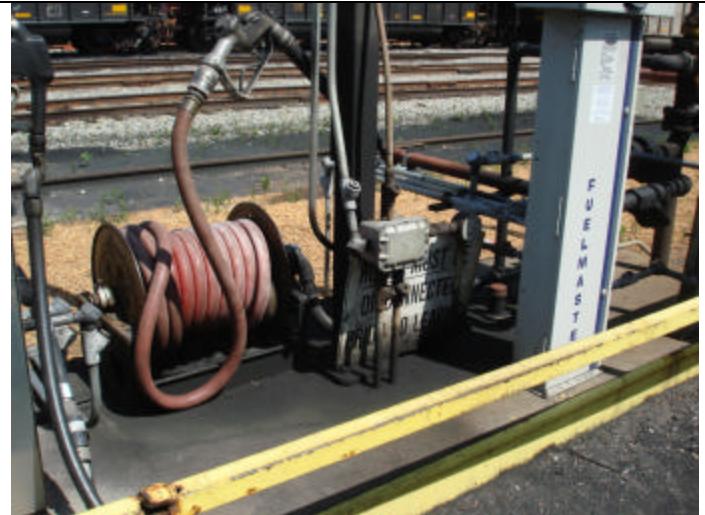
Photo 18. Fuel station.
